Access Compliance Report

Public Rights-of-Way

(Curb Ramps)

Intersection ID: 50615	Main Street: FAWN_LILY	Cross Street: BALSAM_BAY_RD	Location: SW
ADA ID: 2EC439CE8B1F	Ramp Type: Perp	Initial Pass/Fail: Fail	Overall Compliance: No
		Severity Score: 12.5

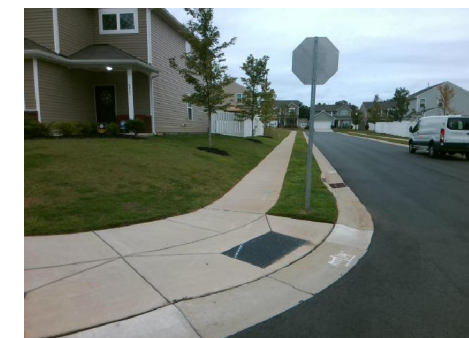
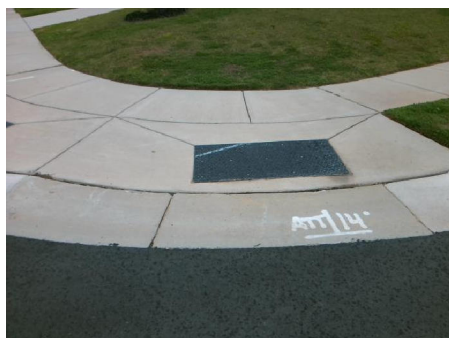
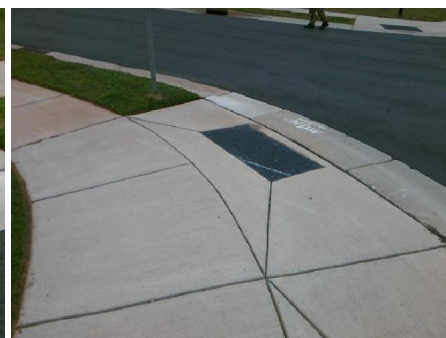
Compliance	Description	Data	Compliance	Description	Data
N/A	Ramp Length (in)	48.0	No	Ramp Slope (%)	11.4
Yes	Ramp Width (in)	48.0	Yes	Ramp XSlope (%)	1.4
N/A	Flare Type LT	N/A	N/A	Flare Type RT	N/A
N/A	Flare Slope LT (%)	N/A	N/A	Flare Slope RT (%)	N/A
N/A	Flare Traversable LT?	N/A	N/A	Flare Traversable RT?	N/A
N/A	Landing Length (in)	N/A	N/A	DWS Provided?	N/A
N/A	Landing Width (in)	N/A	N/A	DWS Contrast?	N/A
N/A	Landing Slope (%)	N/A	N/A	DWS Length (in)	N/A
N/A	Landing X Slope (%)	N/A	N/A	DWS Full Width?	N/A
N/A	Landing Curb? (Y/N)	N/A	N/A	DWS Offset (in)	N/A
N/A	Shared Landing?	N/A			
N/A	Gutter Ponding?	N/A	N/A	Gutter Slope (%)	N/A
N/A	Gutter Lip Ht (in)	N/A	N/A	Gutter X Slope (%)	N/A
N/A	Painted X Walk1?	No	N/A	Painted X Walk2?	N/A
	X Walk 1 Direction	To N		X Walk 2 Direction	N/A
N/A	X Walk 1 Width (in)	N/A	N/A	X Walk 2 Width (in)	N/A
	X Walk 1 Slope (%)	0.9		X Walk 2 Slope (%)	N/A
	X Walk 1 X Slope (%)	0.2		X Walk 2 X Slope (%)	N/A

Remove & Replace Entire Ramp.

Not Found, R304.2.2
