# Access Compliance Report

## Public Rights-of-Way

### (Curb Ramps)

Intersection ID: 32147	Main Street: FOLIO CLUB DR	Cross Street: NEVERMORE_WY	Location: SW
ADA ID: 2ECE5201E3C2	Ramp Type: PerpDiag	Initial Pass/Fail: Fail	Overall Compliance: No
Severity Score: 47.5			
Codes/Mitigation Info/Possible Solution		Field Measurements/Component Compliance

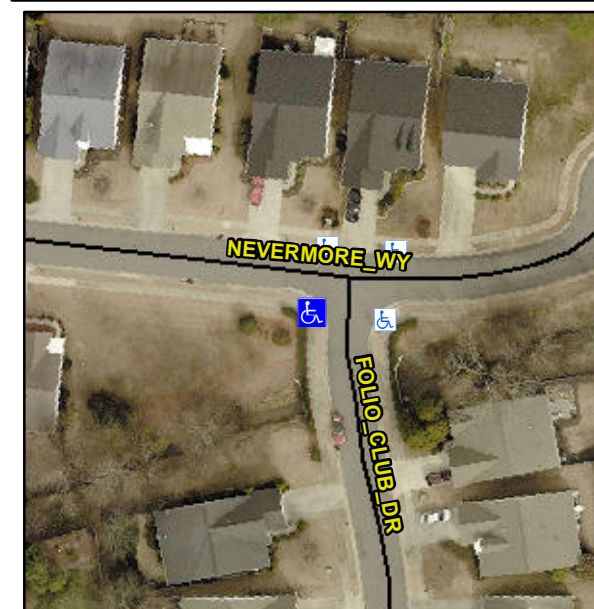
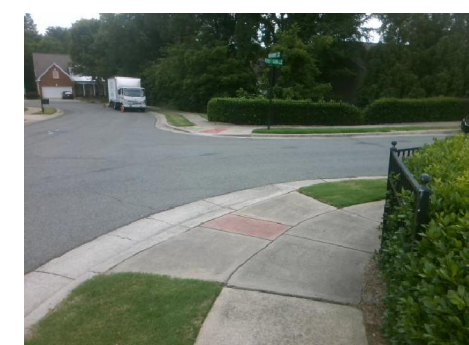
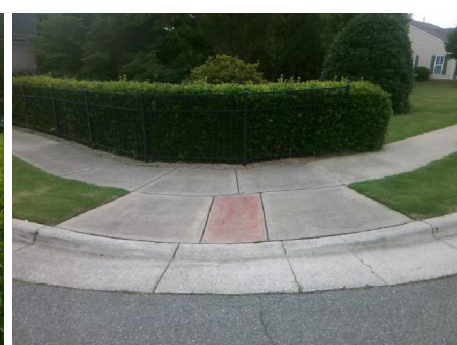
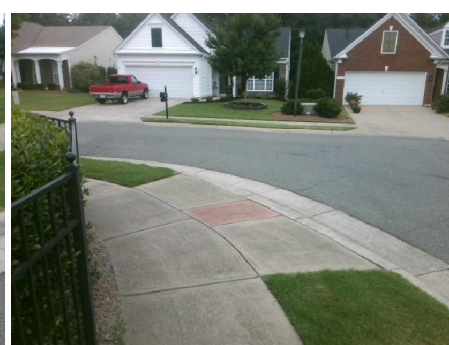
**Not Found, R304.5.1, R304.5.3**

Compliance	Description	Data	Compliance	Description	Data
N/A	Ramp Length (in)	47.0	Yes	Ramp Slope (%)	7.9
No	Ramp Width (in)	24.0	No	Ramp XSlope (%)	5.7
N/A	Flare Type LT	N/A	N/A	Flare Type RT	N/A
N/A	Flare Slope LT (%)	N/A	N/A	Flare Slope RT (%)	N/A
N/A	Flare Traversable LT?	N/A	N/A	Flare Traversable RT?	N/A
N/A	Landing Length (in)	N/A	N/A	DWS Provided?	N/A
N/A	Landing Width (in)	N/A	N/A	DWS Contrast?	N/A
N/A	Landing Slope (%)	N/A	N/A	DWS Length (in)	N/A
N/A	Landing X Slope (%)	N/A	N/A	DWS Full Width?	N/A
N/A	Landing Curb? (Y/N)	N/A	N/A	DWS Offset (in)	N/A
N/A	Shared Landing?	N/A			
N/A	Gutter Ponding?	N/A	N/A	Gutter Slope (%)	N/A
N/A	Gutter Lip Ht (in)	N/A	N/A	Gutter X Slope (%)	N/A
N/A	Painted X Walk1?	No	N/A	Painted X Walk2?	No
	X Walk 1 Direction	To SE		X Walk 2 Direction	To NE
N/A	X Walk 1 Width (in)	N/A	N/A	X Walk 2 Width (in)	N/A
	X Walk 1 Slope (%)	0.9		X Walk 2 Slope (%)	2.0
	X Walk 1 X Slope (%)	4.0		X Walk 2 X Slope (%)	0.7

N/A	Ramp inside XWalk1?	N/A	N/A	Ramp inside XWalk2?	N/A
	Road Slope (%)	2.8	N/A	Clear Space?	N/A
	Road X Slope (%)	2.9	N/A	Clear Space to XWalk (in)	N/A
N/A	Any Obstructions?	N/A	N/A	Storm Grate/Utility Hazard?	N/A
	Obstruction Type			Storm Grate/Utility Type	
		N/A			N/A
			Yes	Surface Condition? (G/P)	Good

**Remove & Replace Curb Ramp With Two New Directional Ramps or Equivalent.**
