Access Compliance Report

Public Rights-of-Way

Intersection ID: 11342	Main Street: GEORGIA_AV	Cross Street: MATHESON_AV	Location: E
ADA ID: 2ECFE1A7E839	Ramp Type: Perp	Initial Pass/Fail: Fail	Overall Compliance: No
Codes/Mitigation Info/Possible Solution		Field Measurements/Component Compliance	
Severity Score: 21.25

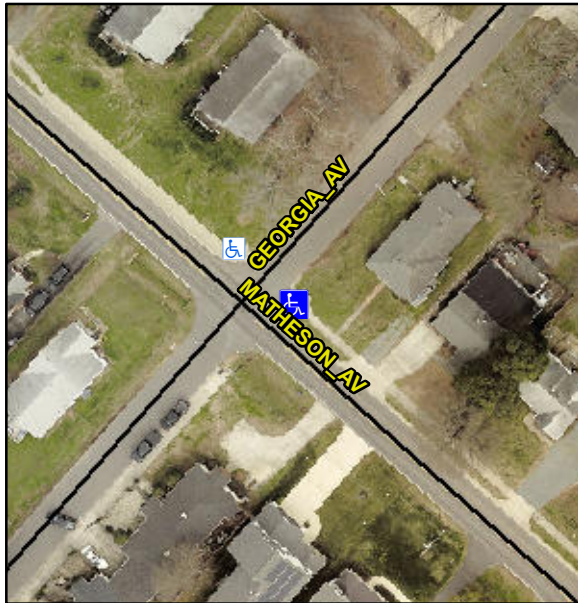
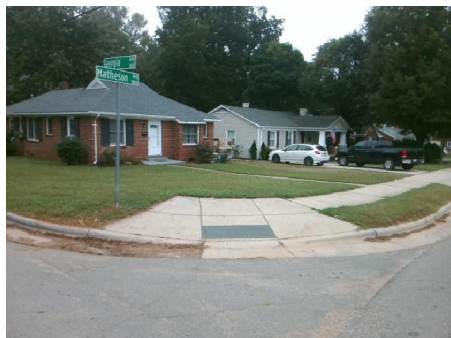
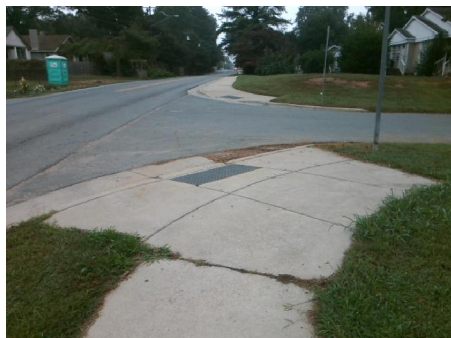
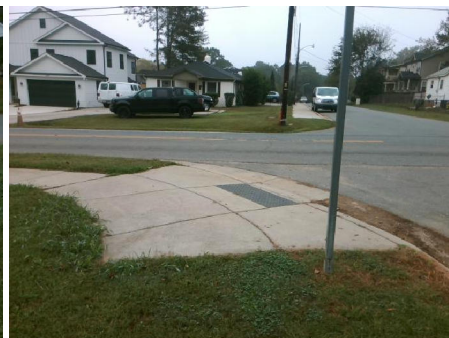
Not Found, R304.5.1, R304.2.2

Compliance	Description	Data	Compliance	Description	Data
N/A	Ramp Length (in)	49.0	No	Ramp Slope (%)	8.7
No	Ramp Width (in)	47.5	Yes	Ramp XSlope (%)	0.3
N/A	Flare Type LT	N/A	N/A	Flare Type RT	N/A
N/A	Flare Slope LT (%)	N/A	N/A	Flare Slope RT (%)	N/A
N/A	Flare Traversable LT?	N/A	N/A	Flare Traversable RT?	N/A
N/A	Landing Length (in)	N/A	N/A	DWS Provided?	N/A
N/A	Landing Width (in)	N/A	N/A	DWS Contrast?	N/A
N/A	Landing Slope (%)	N/A	N/A	DWS Length (in)	N/A
N/A	Landing X Slope (%)	N/A	N/A	DWS Full Width?	N/A
N/A	Landing Curb? (Y/N)	N/A	N/A	DWS Offset (in)	N/A
N/A	Shared Landing?	N/A			
N/A	Gutter Ponding?	N/A	N/A	Gutter Slope (%)	N/A
N/A	Gutter Lip Ht (in)	N/A	N/A	Gutter X Slope (%)	N/A
N/A	Painted X Walk1?	No	N/A	Painted X Walk2?	N/A
	X Walk 1 Direction	To NW		X Walk 2 Direction	N/A
N/A	X Walk 1 Width (in)	N/A	N/A	X Walk 2 Width (in)	N/A
	X Walk 1 Slope (%)	4.9		X Walk 2 Slope (%)	N/A
	X Walk 1 X Slope (%)	2.6		X Walk 2 X Slope (%)	N/A

N/A	Ramp inside XWalk1?	N/A	N/A	Ramp inside XWalk2?	N/A
	Road Slope (%)	N/A	N/A	Clear Space?	N/A
	Road X Slope (%)	N/A	N/A	Clear Space to XWalk (in)	N/A
N/A	Any Obstructions?	N/A	N/A	Storm Grate/Utility Hazard?	N/A
	Obstruction Type			Storm Grate/Utility Type	
		N/A			N/A
			Yes	Surface Condition? (G/P)	Good

Remove & Replace Entire Ramp.
