# Access Compliance Report

## Public Rights-of-Way

### (Curb Ramps)

Intersection ID: 16266	Main Street: BEVERLY_DR	Cross Street: PORTLAND_AV	Location: SE
ADA ID: 2ED8C7CEFE04	Ramp Type: Perp	Initial Pass/Fail: Fail	Overall Compliance: No
Codes/Mitigation Info/Possible Solution		Field Measurements/Component Compliance	
Severity Score: 8.75

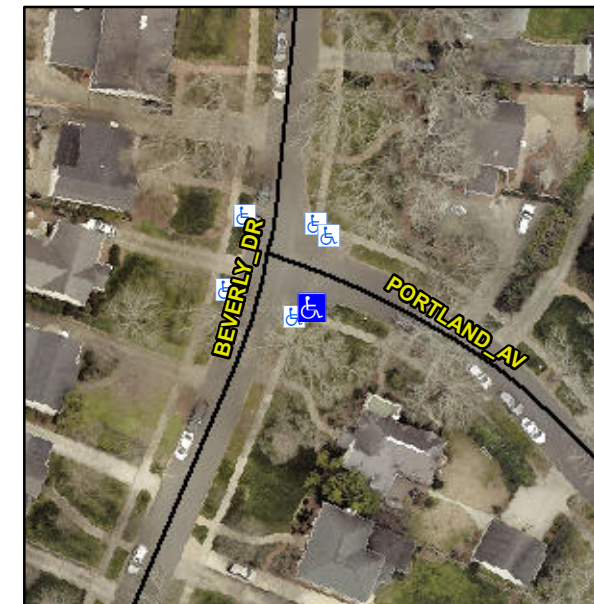
Compliance	Description	Data	Compliance	Description	Data
N/A	Ramp Length (in)	37.0	Yes	Ramp Slope (%)	5.8
No	Ramp Width (in)	47.0	Yes	Ramp XSlope (%)	1.2
N/A	Flare Type LT	N/A	N/A	Flare Type RT	N/A
N/A	Flare Slope LT (%)	N/A	N/A	Flare Slope RT (%)	N/A
N/A	Flare Traversable LT?	N/A	N/A	Flare Traversable RT?	N/A
N/A	Landing Length (in)	N/A	N/A	DWS Provided?	N/A
N/A	Landing Width (in)	N/A	N/A	DWS Contrast?	N/A
N/A	Landing Slope (%)	N/A	N/A	DWS Length (in)	N/A
N/A	Landing X Slope (%)	N/A	N/A	DWS Full Width?	N/A
N/A	Landing Curb? (Y/N)	N/A	N/A	DWS Offset (in)	N/A
N/A	Shared Landing?	N/A			
N/A	Gutter Ponding?	N/A	N/A	Gutter Slope (%)	N/A
N/A	Gutter Lip Ht (in)	N/A	N/A	Gutter X Slope (%)	N/A
N/A	Painted X Walk1?	No	N/A	Painted X Walk2?	N/A
	X Walk 1 Direction	To NE		X Walk 2 Direction	N/A
N/A	X Walk 1 Width (in)	N/A	N/A	X Walk 2 Width (in)	N/A
	X Walk 1 Slope (%)	8.7		X Walk 2 Slope (%)	N/A
	X Walk 1 X Slope (%)	0.2		X Walk 2 X Slope (%)	N/A

N/A	Ramp inside XWalk1?	N/A	N/A	Ramp inside XWalk2?	N/A
	Road Slope (%)	N/A	N/A	Clear Space?	N/A
	Road X Slope (%)	N/A	N/A	Clear Space to XWalk (in)	N/A
N/A	Any Obstructions?	N/A	N/A	Storm Grate/Utility Hazard?	N/A
	Obstruction Type			Storm Grate/Utility Type	
		N/A			N/A
			Yes	Surface Condition? (G/P)	Good

**Remove & Replace Entire Ramp.**

**R304.5.1**
