## **Access Compliance Report Public Rights-of-Way** (Curb Ramps)

Intersection ID: 28402 Main Street: HAWFIELD WAY DR **Cross Street: LANCASTER HY** Location: NE **ADA ID: 2EDE6B11B13B** Ramp Type: BlendTrans2 Initial Pass/Fail: Fail **Overall Compliance: No Severity Score:** 1.25

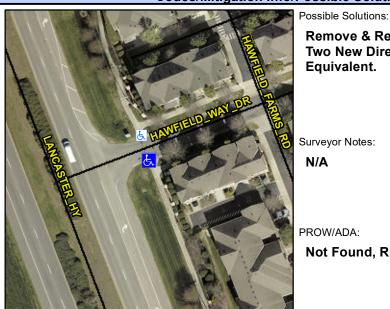
Not Found, R304.5.3

Yes	Ramp Width (in)	48.0	No	BlendTrans XSlope (%)	2.1
N/A	Flare Type LT	N/A	N/A	Flare Type RT	N/A
N/A	Flare Slope LT (%)	N/A	N/A	Flare Slope RT (%)	N/A
N/A	Flare Traversable LT?	N/A	N/A	Flare Traversable RT?	N/A
N/A	Landing Length (in)	N/A	N/A	DWS Provided?	N/A
N/A	Landing Width (in)	N/A	N/A	DWS Contrast?	N/A
N/A	Landing Slope (%)	N/A	N/A	DWS Length (in)	N/A
N/A	Landing X Slope (%)	N/A	N/A	DWS Full Width?	N/A
N/A	Landing Curb? (Y/N)	N/A	N/A	DWS Offset (in)	N/A
N/A	Shared Landing?	N/A			
N/A	Gutter Ponding?	N/A	N/A	Gutter Slope (%)	N/A
N/A	Gutter Lip Ht (in)	N/A	N/A	Gutter X Slope (%)	N/A
N/A	Painted X Walk1?	No	N/A	Painted X Walk2?	N/A
	X Walk 1 Direction	To NW		X Walk 2 Direction	N/A
	X Walk 1 Width (in)	N/A		X Walk 2 Width (in)	N/A
	X Walk 1 Slope (%)	0.3		X Walk 2 Slope (%)	N/A
	X Walk 1 X Slope (%)	3.9		X Walk 2 X Slope (%)	N/A
N/A	Ramp inside XWalk1?	N/A	N/A	Ramp inside XWalk2?	N/A
	Road Slope (%)	3.9		Clear Space?	N/A

Road X Slope (%)	0.3	N/A	Clear Space to XWalk (in)	N/A
N/A	Any Obstructions?	N/A	N/A	Storm Grate/Utility Hazard?	N/A
	Obstruction Type		l	Storm Grate/Utility Type	
		N/A	l		N/A
			Yes	Surface Condition? (G/P)	Good
			No	Curb Slope (%)	7.3
LANGUSTES 22 The

**Remove & Replace Curb Ramp With** Two New Directional Ramps or Equivalent.

> Total Cost: 3200.00
