## Access Compliance Report Public Rights-of-Way (Curb Ramps)

Intersection ID: 2899Main Street:RIDGE\_RDCross Street:WAVERLY\_LYNN\_LNLocation:NWADA ID: 2EDF48019586Ramp Type:PerpInitial Pass/Fail:FailOverall Compliance:NoSeverity Score:25

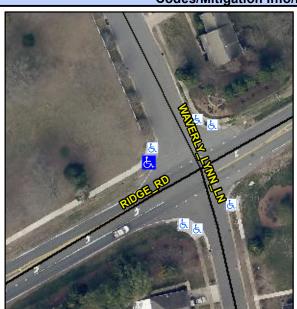
Field Measurements/Component Compliance							
Comp	Data	Compliance Description		Data			
N/A	Ramp Length (in)	63.0	Yes	Ramp Slope (%)	5.6		
Yes	Ramp Width (in)	48.0	No	Ramp XSlope (%)	8.3		
N/A	Flare Type LT	N/A	N/A	Flare Type RT	N/A		
N/A	Flare Slope LT (%)	N/A	N/A	Flare Slope RT (%)	N/A		
N/A	Flare Traversable LT?	N/A	N/A	Flare Traversable RT?	N/A		
N/A	Landing Length (in)	N/A	N/A	DWS Provided?	N/A		
N/A	Landing Width (in)	N/A	N/A	DWS Contrast?	N/A		
N/A	Landing Slope (%)	N/A	N/A	DWS Length (in)	N/A		
N/A	Landing X Slope (%)	N/A	N/A	DWS Full Width?	N/A		
N/A	Landing Curb? (Y/N)	N/A	N/A	DWS Offset (in)	N/A		
N/A	Shared Landing?	N/A					
N/A	Gutter Ponding?	N/A	N/A	Gutter Slope (%)	N/A		
N/A	Gutter Lip Ht (in)	N/A	N/A	Gutter X Slope (%)	N/A		
N/A	Painted X Walk1?	No	N/A	Painted X Walk2?	N/A		
	X Walk 1 Direction	To S		X Walk 2 Direction	N/A		
N/A	X Walk 1 Width (in)	N/A	N/A	X Walk 2 Width (in)	N/A		
	X Walk 1 Slope (%)	7.1		X Walk 2 Slope (%)	N/A

X Walk 1 X Slope (%)	3.4		X Walk 2 X Slope (%)	N/A		
N/A	Ramp inside XWalk1?	N/A	N/A	Ramp inside XWalk2?	N/A		
	Road Slope (%)	N/A	N/A	Clear Space?	N/A		
	Road X Slope (%)	N/A	N/A	Clear Space to XWalk (in)	N/A		
N/A	Any Obstructions?	N/A	N/A	Storm Grate/Utility Hazard?	N/A		
	Obstruction Type			Storm Grate/Utility Type			
		N/A			N/A		
			Yes	Surface Condition? (G/P)	Good

Possible Solutions:				
The Late of the la	Remove & Replace Entire Ramp.				
Sec. Act	Surveyor Notes:				
	N/A				
	PROW/ADA:				
The second second	R304.5.3

Total Cost: \$ 1850.00
