Access Compliance Report

Public Rights-of-Way

(Curb Ramps)

Intersection ID: 10022823	Main Street: CASTLE_WATCH_AV	Cross Street: N/A	Location: NE
ADA ID: 2EE386656973	Ramp Type: PerpDiag	Initial Pass/Fail: Fail	Overall Compliance: No
Severity Score: 22.5			
Codes/Mitigation Info/Possible Solution		Field Measurements/Component Compliance

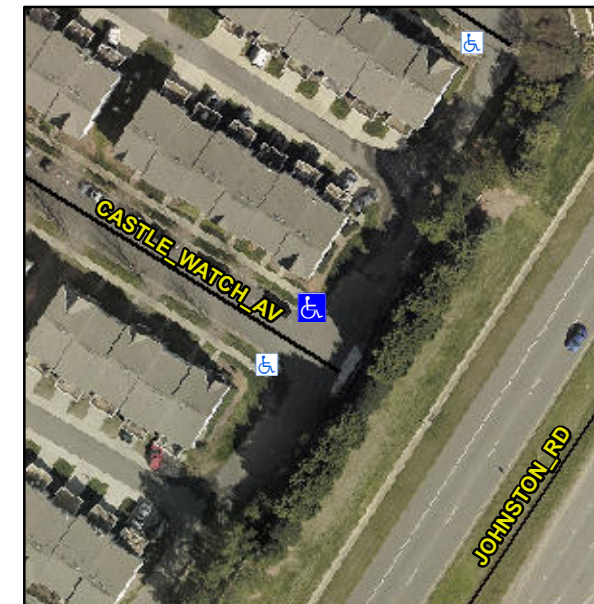
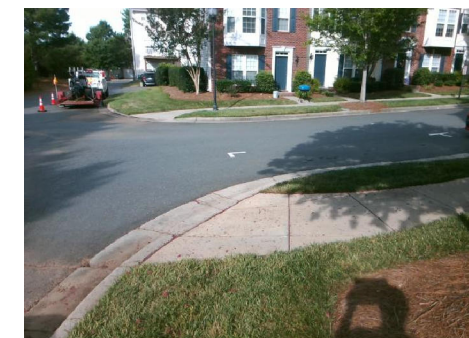
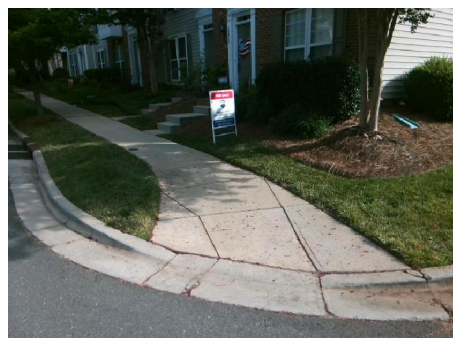
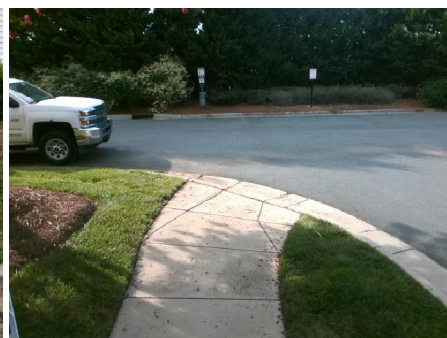
Compliance	Description	Data	Compliance	Description	Data
N/A	Ramp Length (in)	78.0	No	Ramp Slope (%)	11.4
No	Ramp Width (in)	36.0	No	Ramp XSlope (%)	2.2
N/A	Flare Type LT	N/A	N/A	Flare Type RT	N/A
N/A	Flare Slope LT (%)	N/A	N/A	Flare Slope RT (%)	N/A
N/A	Flare Traversable LT?	N/A	N/A	Flare Traversable RT?	N/A
N/A	Landing Length (in)	N/A	N/A	DWS Provided?	N/A
N/A	Landing Width (in)	N/A	N/A	DWS Contrast?	N/A
N/A	Landing Slope (%)	N/A	N/A	DWS Length (in)	N/A
N/A	Landing X Slope (%)	N/A	N/A	DWS Full Width?	N/A
N/A	Landing Curb? (Y/N)	N/A	N/A	DWS Offset (in)	N/A
N/A	Shared Landing?	N/A			
N/A	Gutter Ponding?	N/A	N/A	Gutter Slope (%)	N/A
N/A	Gutter Lip Ht (in)	N/A	N/A	Gutter X Slope (%)	N/A
N/A	Painted X Walk1?	No	N/A	Painted X Walk2?	No
	X Walk 1 Direction	To SW		X Walk 2 Direction	To SE
N/A	X Walk 1 Width (in)	N/A	N/A	X Walk 2 Width (in)	N/A
	X Walk 1 Slope (%)	0.3		X Walk 2 Slope (%)	1.6
	X Walk 1 X Slope (%)	2.2		X Walk 2 X Slope (%)	0.3

N/A	Ramp inside XWalk1?	N/A	N/A	Ramp inside XWalk2?	N/A
	Road Slope (%)	1.6	N/A	Clear Space?	N/A
	Road X Slope (%)	2.7	N/A	Clear Space to XWalk (in)	N/A
N/A	Any Obstructions?	N/A	N/A	Storm Grate/Utility Hazard?	N/A
	Obstruction Type			Storm Grate/Utility Type	
		N/A			N/A
			Yes	Surface Condition? (G/P)	Good

Remove & Replace Curb Ramp With Two New Directional Ramps or Equivalent.
