# Access Compliance Report

## Public Rights-of-Way

### (Curb Ramps)

Intersection ID: N/A	Main Street: S COLLEGE ST	Cross Street: E HILL ST	Location: S
ADA ID: 2EF8E69517C1	Ramp Type: Perp	Initial Pass/Fail: Pass	Overall Compliance: No
			Severity Score: 2.75

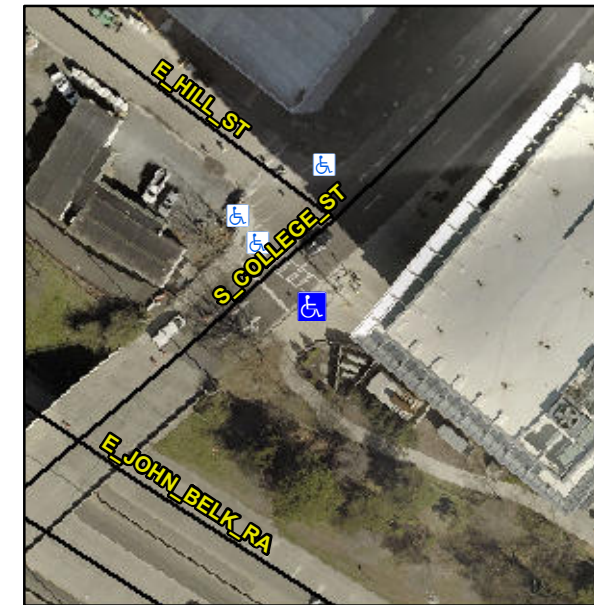
**Not Found, R304.2.3, R304.5.3**

Compliance	Description	Data	Compliance	Description	Data
N/A	Ramp Length (in)	96.0	Yes	Ramp Slope (%)	5.4
Yes	Ramp Width (in)	59.5	Yes	Ramp XSlope (%)	3.1
N/A	Flare Type LT	Sloped	N/A	Flare Type RT	N/A
N/A	Flare Slope LT (%)	4.7	No	Flare Slope RT (%)	10.7
N/A	Flare Traversable LT?	Yes	N/A	Flare Traversable RT?	Yes
Yes	Landing Length (in)	51.0	Yes	DWS Provided?	Yes
Yes	Landing Width (in)	59.0	Yes	DWS Contrast?	Yes
Yes	Landing Slope (%)	1.4	Yes	DWS Length (in)	24.0
Yes	Landing X Slope (%)	1.7	Yes	DWS Full Width?	Yes
N/A	Landing Curb? (Y/N)	No	Yes	DWS Offset (in)	0.0
N/A	Shared Landing?	No			
Yes	Gutter Ponding?	No	Yes	Gutter Slope (%)	0.8
Yes	Gutter Lip Ht (in)	0.0	No	Gutter X Slope (%)	5.2
N/A	Painted X Walk1?	Yes	N/A	Painted X Walk2?	N/A
	X Walk 1 Direction	To N		X Walk 2 Direction	N/A
N/A	X Walk 1 Width (in)	105.0	N/A	X Walk 2 Width (in)	N/A
	X Walk 1 Slope (%)	0.6		X Walk 2 Slope (%)	N/A
	X Walk 1 X Slope (%)	4.6		X Walk 2 X Slope (%)	N/A

Yes	Ramp inside XWalk1?	Yes	N/A	Ramp inside XWalk2?	N/A
	Road Slope (%)	N/A	N/A	Clear Space?	Yes
	Road X Slope (%)	N/A	N/A	Clear Space to XWalk (in)	N/A
Yes	Any Obstructions?	No	Yes	Storm Grate/Utility Hazard?	No
	Obstruction Type			Storm Grate/Utility Type	
			N/A		N/A
			Yes	Surface Condition? (G/P)	Good

**Remove & Replace Entire Ramp.  
Remove & Replace Gutter.**
