Access Compliance Report

Public Rights-of-Way

(Curb Ramps)

Intersection ID: 18272	Main Street: MCLAUGHLIN_DR	Cross Street: MONROE_RD	Location: SW
ADA ID: 2EFAF6FC6E78	Ramp Type: PerpDiag	Initial Pass/Fail: Fail	Overall Compliance: No
		Severity Score: 25

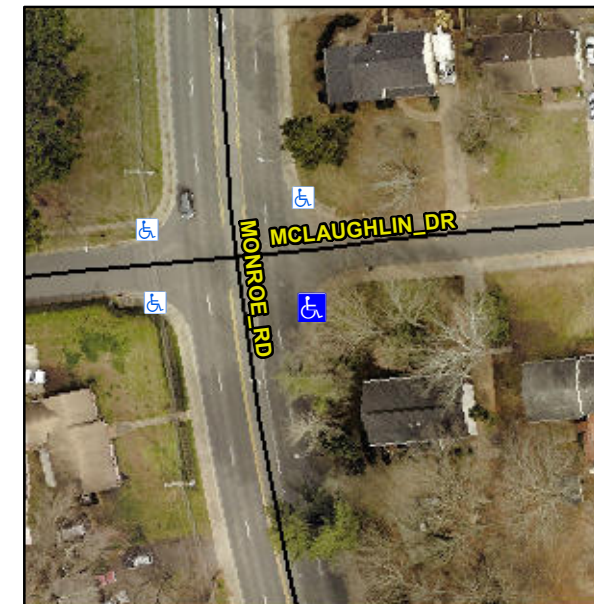
Compliance	Description	Data	Compliance	Description	Data
N/A	Ramp Length (in)	60.0	No	Ramp Slope (%)	11.3
Yes	Ramp Width (in)	48.0	No	Ramp XSlope (%)	5.1
N/A	Flare Type LT	N/A	N/A	Flare Type RT	N/A
N/A	Flare Slope LT (%)	N/A	N/A	Flare Slope RT (%)	N/A
N/A	Flare Traversable LT?	N/A	N/A	Flare Traversable RT?	N/A
N/A	Landing Length (in)	N/A	N/A	DWS Provided?	N/A
N/A	Landing Width (in)	N/A	N/A	DWS Contrast?	N/A
N/A	Landing Slope (%)	N/A	N/A	DWS Length (in)	N/A
N/A	Landing X Slope (%)	N/A	N/A	DWS Full Width?	N/A
N/A	Landing Curb? (Y/N)	N/A	N/A	DWS Offset (in)	N/A
N/A	Shared Landing?	N/A			
N/A	Gutter Ponding?	N/A	N/A	Gutter Slope (%)	N/A
N/A	Gutter Lip Ht (in)	N/A	N/A	Gutter X Slope (%)	N/A
N/A	Painted X Walk1?	No	N/A	Painted X Walk2?	No
	X Walk 1 Direction	To N		X Walk 2 Direction	To W
N/A	X Walk 1 Width (in)	N/A	N/A	X Walk 2 Width (in)	N/A
	X Walk 1 Slope (%)	3.3		X Walk 2 Slope (%)	2.8
	X Walk 1 X Slope (%)	3.1		X Walk 2 X Slope (%)	2.1

N/A	Ramp inside XWalk1?	N/A	N/A	Ramp inside XWalk2?	N/A
	Road Slope (%)	3.1	N/A	Clear Space?	N/A
	Road X Slope (%)	0.6	N/A	Clear Space to XWalk (in)	N/A
N/A	Any Obstructions?	N/A	N/A	Storm Grate/Utility Hazard?	N/A
	Obstruction Type			Storm Grate/Utility Type	
		N/A			N/A
			Yes	Surface Condition? (G/P)	Good

Remove & Replace Curb Ramp With Two New Directional Ramps or Equivalent.
