Access Compliance Report

Public Rights-of-Way

(Curb Ramps)

Intersection ID: 10147	Main Street: E_27TH_ST	Cross Street: N_TRYON_ST	Location: SE
ADA ID: 2F04F25CA105	Ramp Type: Perp	Initial Pass/Fail: Fail	Overall Compliance: No
			Severity Score: 33.75

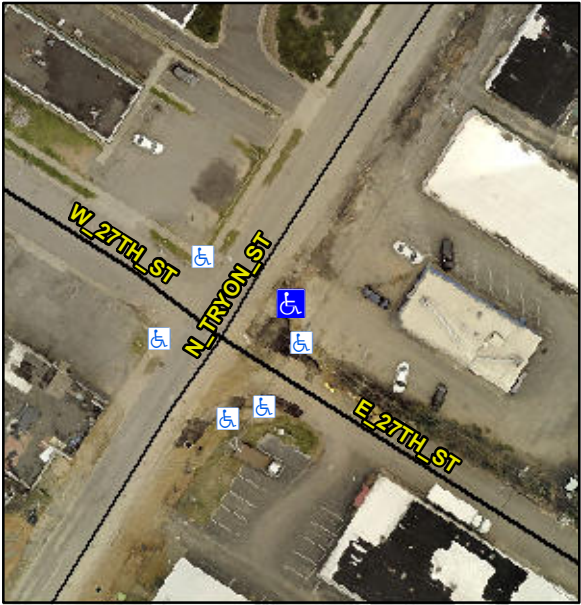
Possible Solutions:		Compliance	Description	Data
	Remove & Replace Entire Ramp.		N/A	Ramp Length (in)	61.5
			No	Ramp Width (in)	45.0
			N/A	Flare Type LT	N/A
			N/A	Flare Slope LT (%)	N/A
			N/A	Flare Traversable LT?	N/A
			N/A	Landing Length (in)	N/A
			N/A	Landing Width (in)	N/A
			N/A	Landing Slope (%)	N/A
			N/A	Landing X Slope (%)	N/A
<p>Surveyor Notes:</p> <p>N/A</p> <p>PROW/ADA:</p> <p>Not Found, R304.5.1, R304.2.2</p>			N/A	Flare Type RT	N/A
			N/A	Flare Slope RT (%)	N/A
			N/A	Flare Traversable RT?	N/A
			N/A	DWS Provided?	N/A
			N/A	DWS Contrast?	N/A
			N/A	DWS Length (in)	N/A
			N/A	DWS Full Width?	N/A
			N/A	DWS Offset (in)	N/A
			N/A	Shared Landing?	N/A
			N/A	Gutter Ponding?	N/A
			N/A	Gutter Lip Ht (in)	1.0
			N/A	Painted X Walk1?	No
				X Walk 1 Direction	To NW
			N/A	X Walk 1 Width (in)	N/A
				X Walk 1 Slope (%)	2.3

X Walk 1 X Slope (%)	2.7
			N/A	Ramp inside XWalk1?	N/A
				Road Slope (%)	N/A
				Road X Slope (%)	N/A
			N/A	Any Obstructions?	N/A
				Obstruction Type	
Total Cost:		\$ 1850.00			
			N/A		N/A
			Yes	Surface Condition? (G/P)	Good
