# Access Compliance Report

## Public Rights-of-Way

### (Curb Ramps)

Intersection ID: 12869	Main Street: E_TRADE_ST	Cross Street: N_ALEXANDER_ST	Location: S
ADA ID: 2F28DBC5664F	Ramp Type: PerpDiag	Initial Pass/Fail: Fail	Overall Compliance: No
Severity Score: 12.5			
Codes/Mitigation Info/Possible Solution		Field Measurements/Component Compliance

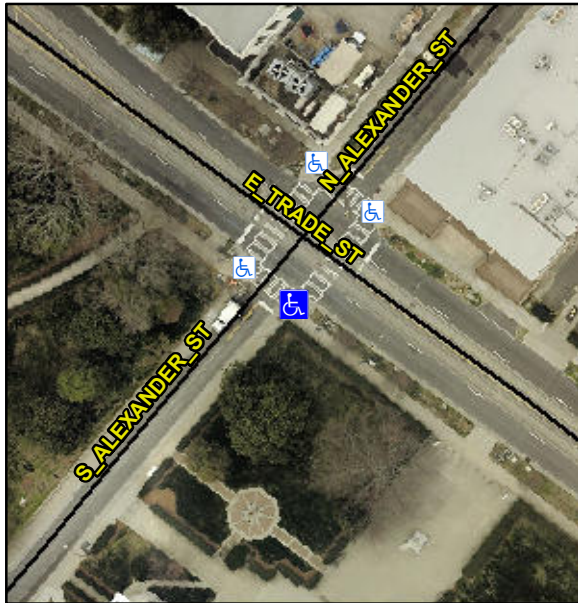
**Not Found, R304.5.3**

Compliance	Description	Data	Compliance	Description	Data
N/A	Ramp Length (in)	76.0	Yes	Ramp Slope (%)	5.5
Yes	Ramp Width (in)	48.0	No	Ramp XSlope (%)	5.4
N/A	Flare Type LT	N/A	N/A	Flare Type RT	N/A
N/A	Flare Slope LT (%)	N/A	N/A	Flare Slope RT (%)	N/A
N/A	Flare Traversable LT?	N/A	N/A	Flare Traversable RT?	N/A
N/A	Landing Length (in)	N/A	N/A	DWS Provided?	N/A
N/A	Landing Width (in)	N/A	N/A	DWS Contrast?	N/A
N/A	Landing Slope (%)	N/A	N/A	DWS Length (in)	N/A
N/A	Landing X Slope (%)	N/A	N/A	DWS Full Width?	N/A
N/A	Landing Curb? (Y/N)	N/A	N/A	DWS Offset (in)	N/A
N/A	Shared Landing?	N/A			
N/A	Gutter Ponding?	N/A	N/A	Gutter Slope (%)	N/A
N/A	Gutter Lip Ht (in)	N/A	N/A	Gutter X Slope (%)	N/A
N/A	Painted X Walk1?	Yes	N/A	Painted X Walk2?	Yes
	X Walk 1 Direction	To NE		X Walk 2 Direction	To NW
N/A	X Walk 1 Width (in)	111.0	N/A	X Walk 2 Width (in)	109.0
	X Walk 1 Slope (%)	3.4		X Walk 2 Slope (%)	4.0
	X Walk 1 X Slope (%)	4.2		X Walk 2 X Slope (%)	0.9

N/A	Ramp inside XWalk1?	Yes	N/A	Ramp inside XWalk2?	Yes
	Road Slope (%)	1.0	N/A	Clear Space?	N/A
	Road X Slope (%)	2.9	N/A	Clear Space to XWalk (in)	N/A
N/A	Any Obstructions?	N/A	N/A	Storm Grate/Utility Hazard?	N/A
	Obstruction Type			Storm Grate/Utility Type	
		N/A			N/A
		Yes		Surface Condition? (G/P)	Good

Possible Solutions:

**Remove & Replace Curb Ramp With Two New Directional Ramps or Equivalent.**

Total Cost: \$ **3200.00**
