Access Compliance Report Public Rights-of-Way (Curb Ramps)

Intersection ID: 28744 Main Street: PLEASANT_PLAINS_RD Cross Street: SAVANNAH_HILLS_DR Location: SW

ADA ID: 2F29FEBEAB30 Ramp Type: Perp Initial Pass/Fail: Fail Overall Compliance: No Severity Score: 10

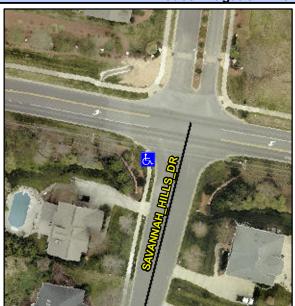
Not Found, R304.5.1, R304.5.3

Yes N/A Ramp Length (in) 49.0 Ramp Slope (%) 7.0 40.5 No Ramp XSlope (%) No Ramp Width (in) 2.9 N/A N/A Flare Type LT N/A Flare Type RT N/A N/A Flare Slope LT (%) N/A N/A Flare Slope RT (%) N/A N/A Flare Traversable LT? N/A N/A Flare Traversable RT? N/A N/A Landing Length (in) N/A N/A **DWS Provided?** N/A N/A Landing Width (in) N/A N/A **DWS Contrast?** N/A N/A N/A N/A Landing Slope (%) DWS Length (in) N/A N/A Landing X Slope (%) N/A N/A DWS Full Width? N/A N/A Landing Curb? (Y/N) N/A N/A DWS Offset (in) N/A N/A N/A Shared Landing? N/A **Gutter Ponding?** N/A N/A Gutter Slope (%) N/A N/A Gutter Lip Ht (in) N/A N/A Gutter X Slope (%) N/A N/A Painted X Walk1? No N/A Painted X Walk2? N/A X Walk 1 Direction To N X Walk 2 Direction N/A N/A N/A X Walk 2 Width (in) X Walk 1 Width (in) N/A N/A X Walk 1 Slope (%) 4.7 X Walk 2 Slope (%) N/A X Walk 1 X Slope (%) 1.2 X Walk 2 X Slope (%) N/A N/A N/A N/A Ramp inside XWalk2? Ramp inside XWalk1? N/A Road Slope (%) N/A N/A Clear Space? N/A N/A Road X Slope (%) N/A Clear Space to XWalk (in) N/A N/A N/A Any Obstructions? N/A Storm Grate/Utility Hazard? N/A **Obstruction Type** Storm Grate/Utility Type N/A N/A Yes Surface Condition? (G/P) Good

Remove & Replace Entire Ramp.
