Access Compliance Report

Public Rights-of-Way

(Curb Ramps)

Intersection ID: 54317	Main Street: BELMONT_MANSION_DR	Cross Street: SOUTHRIDGE_FOREST_DR	Location: SW
ADA ID: 2F3066C69B27	Ramp Type: BlendTrans1	Initial Pass/Fail: Fail	Overall Compliance: No
Codes/Mitigation Info/Possible Solution		Field Measurements/Component Compliance	
Severity Score: 21.25

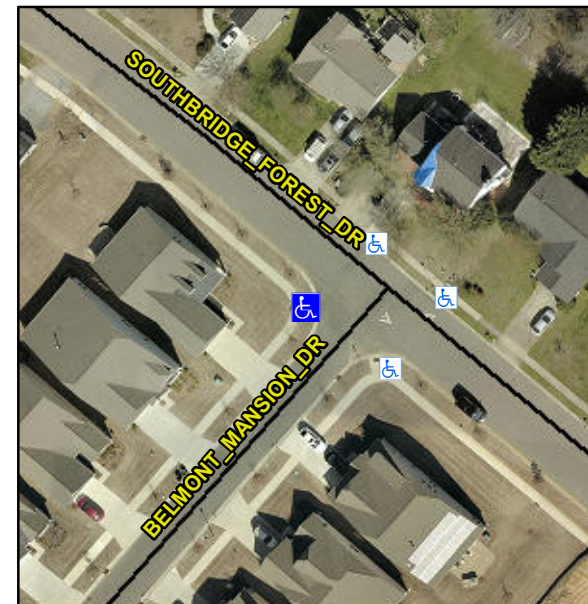
Compliance	Description	Data	Compliance	Description	Data
N/A	Ramp Length (in)	94.0	Yes	BlendTrans Slope (%)	3.6
No	Ramp Width (in)	46.0	No	BlendTrans XSlope (%)	5.4
N/A	Flare Type LT	N/A	N/A	Flare Type RT	N/A
N/A	Flare Slope LT (%)	N/A	N/A	Flare Slope RT (%)	N/A
N/A	Flare Traversable LT?	N/A	N/A	Flare Traversable RT?	N/A
N/A	Landing Length (in)	N/A	N/A	DWS Provided?	N/A
N/A	Landing Width (in)	N/A	N/A	DWS Contrast?	N/A
N/A	Landing Slope (%)	N/A	N/A	DWS Length (in)	N/A
N/A	Landing X Slope (%)	N/A	N/A	DWS Full Width?	N/A
N/A	Landing Curb? (Y/N)	N/A	N/A	DWS Offset (in)	N/A
N/A	Shared Landing?	N/A			
N/A	Gutter Ponding?	N/A	N/A	Gutter Slope (%)	N/A
N/A	Gutter Lip Ht (in)	N/A	N/A	Gutter X Slope (%)	N/A
N/A	Painted X Walk1?	No	N/A	Painted X Walk2?	No
	X Walk 1 Direction	To NE		X Walk 2 Direction	To NW
	X Walk 1 Width (in)	N/A		X Walk 2 Width (in)	N/A
	X Walk 1 Slope (%)	1.4		X Walk 2 Slope (%)	2.4
	X Walk 1 X Slope (%)	0.9		X Walk 2 X Slope (%)	2.1

N/A	Ramp inside XWalk1?	N/A	N/A	Ramp inside XWalk2?	N/A
	Road Slope (%)	5.5		Clear Space?	N/A
	Road X Slope (%)	3.9	N/A	Clear Space to XWalk (in)	N/A
N/A	Any Obstructions?	N/A	N/A	Storm Grate/Utility Hazard?	N/A
	Obstruction Type			Storm Grate/Utility Type	
		N/A			N/A
			Yes	Surface Condition? (G/P)	Good
			N/A	Curb Slope (%)	0.9

Possible Solutions:

Remove & Replace Curb Ramp With Two New Directional Ramps or Equivalent.

R304.5.1, R304.5.3
