Access Compliance Report

Public Rights-of-Way

(Curb Ramps)

Intersection ID: 13877	Main Street: MYRTLE_AV	Cross Street: TEMPLETON_AV	Location:	N
ADA ID: 2F3564CA8288	Ramp Type: PerpDiag	Initial Pass/Fail: Fail	Overall Compliance: No	Severity Score: 12.5
Codes/Mitigation Info/Possible Solution		Field Measurements/Component Compliance

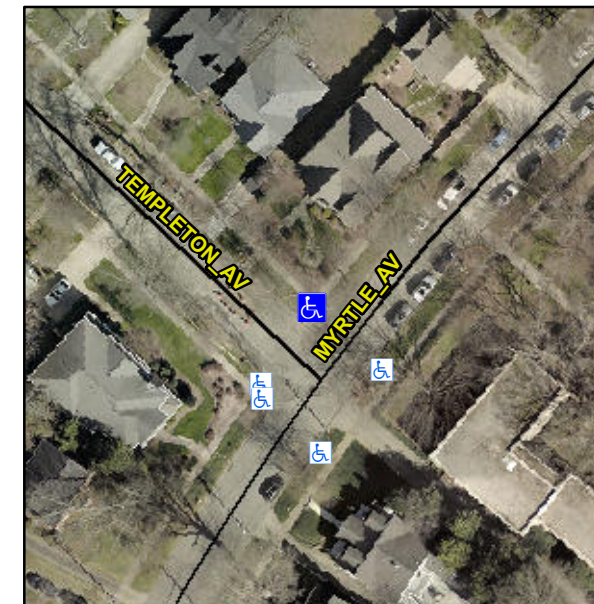
Not Found, R304.2.2

Compliance	Description	Data	Compliance	Description	Data
N/A	Ramp Length (in)	83.0	No	Ramp Slope (%)	9.1
Yes	Ramp Width (in)	60.0	Yes	Ramp XSlope (%)	1.0
N/A	Flare Type LT	N/A	N/A	Flare Type RT	N/A
N/A	Flare Slope LT (%)	N/A	N/A	Flare Slope RT (%)	N/A
N/A	Flare Traversable LT?	N/A	N/A	Flare Traversable RT?	N/A
N/A	Landing Length (in)	N/A	N/A	DWS Provided?	N/A
N/A	Landing Width (in)	N/A	N/A	DWS Contrast?	N/A
N/A	Landing Slope (%)	N/A	N/A	DWS Length (in)	N/A
N/A	Landing X Slope (%)	N/A	N/A	DWS Full Width?	N/A
N/A	Landing Curb? (Y/N)	N/A	N/A	DWS Offset (in)	N/A
N/A	Shared Landing?	N/A			
N/A	Gutter Ponding?	Yes	N/A	Gutter Slope (%)	N/A
N/A	Gutter Lip Ht (in)	N/A	N/A	Gutter X Slope (%)	N/A
N/A	Painted X Walk1?	No	N/A	Painted X Walk2?	No
	X Walk 1 Direction	To SW		X Walk 2 Direction	To SE
N/A	X Walk 1 Width (in)	N/A	N/A	X Walk 2 Width (in)	N/A
	X Walk 1 Slope (%)	2.6		X Walk 2 Slope (%)	2.0
	X Walk 1 X Slope (%)	0.6		X Walk 2 X Slope (%)	1.5

N/A	Ramp inside XWalk1?	N/A	N/A	Ramp inside XWalk2?	N/A
	Road Slope (%)	0.3	N/A	Clear Space?	N/A
	Road X Slope (%)	4.1	N/A	Clear Space to XWalk (in)	N/A
N/A	Any Obstructions?	N/A	N/A	Storm Grate/Utility Hazard?	N/A
	Obstruction Type			Storm Grate/Utility Type	
		N/A			N/A
			Yes	Surface Condition? (G/P)	Good

Remove & Replace Curb Ramp With Two New Directional Ramps or Equivalent.

Total Cost: \$ 3200.00
