Access Compliance Report

Public Rights-of-Way

Intersection ID: 17711	Main Street: CASTLETON_RD	Cross Street: CHARLESTOWNE_MANOR_DR	Location: S
ADA ID: 2F36A482B5CE	Ramp Type: PerpDiag	Initial Pass/Fail: Fail	Overall Compliance: No
		Severity Score: 12.5

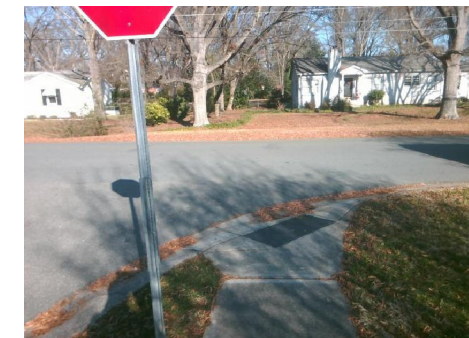
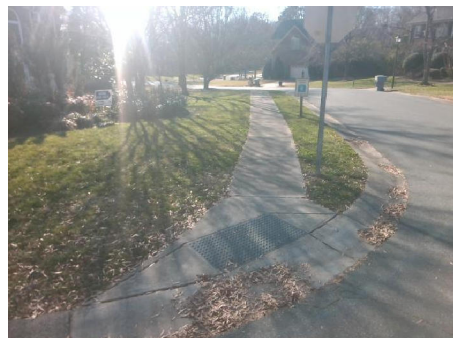
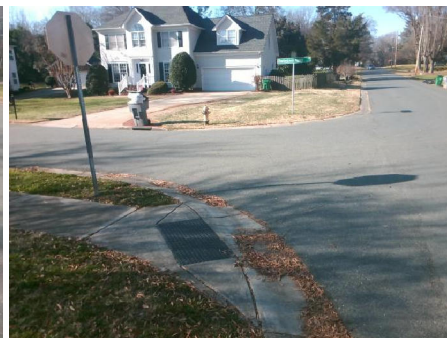
Compliance	Description	Data	Compliance	Description	Data
N/A	Ramp Length (in)	25.0	No	Ramp Slope (%)	8.7
Yes	Ramp Width (in)	48.0	Yes	Ramp XSlope (%)	1.5
N/A	Flare Type LT	N/A	N/A	Flare Type RT	N/A
N/A	Flare Slope LT (%)	N/A	N/A	Flare Slope RT (%)	N/A
N/A	Flare Traversable LT?	N/A	N/A	Flare Traversable RT?	N/A
N/A	Landing Length (in)	N/A	N/A	DWS Provided?	N/A
N/A	Landing Width (in)	N/A	N/A	DWS Contrast?	N/A
N/A	Landing Slope (%)	N/A	N/A	DWS Length (in)	N/A
N/A	Landing X Slope (%)	N/A	N/A	DWS Full Width?	N/A
N/A	Landing Curb? (Y/N)	N/A	N/A	DWS Offset (in)	N/A
N/A	Shared Landing?	N/A			
N/A	Gutter Ponding?	N/A	N/A	Gutter Slope (%)	N/A
N/A	Gutter Lip Ht (in)	N/A	N/A	Gutter X Slope (%)	N/A
N/A	Painted X Walk1?	No	N/A	Painted X Walk2?	No
	X Walk 1 Direction	To NE		X Walk 2 Direction	To NW
N/A	X Walk 1 Width (in)	N/A	N/A	X Walk 2 Width (in)	N/A
	X Walk 1 Slope (%)	2.0		X Walk 2 Slope (%)	1.1
	X Walk 1 X Slope (%)	1.3		X Walk 2 X Slope (%)	1.9

N/A	Ramp inside XWalk1?	N/A	N/A	Ramp inside XWalk2?	N/A
	Road Slope (%)	2.4	N/A	Clear Space?	N/A
	Road X Slope (%)	9.1	N/A	Clear Space to XWalk (in)	N/A
N/A	Any Obstructions?	N/A	N/A	Storm Grate/Utility Hazard?	N/A
	Obstruction Type			Storm Grate/Utility Type	
		N/A			N/A
			Yes	Surface Condition? (G/P)	Good

Remove & Replace Curb Ramp With Two New Directional Ramps or Equivalent.
