Access Compliance Report

Public Rights-of-Way

(Curb Ramps)

Intersection ID: N/A	Main Street: WOODLAWN_ST	Cross Street: N/A	Location: SW
ADA ID: 2F36F60C6B8D	Ramp Type: Directional1	Initial Pass/Fail: Fail	Overall Compliance: No
		Severity Score: 12.5

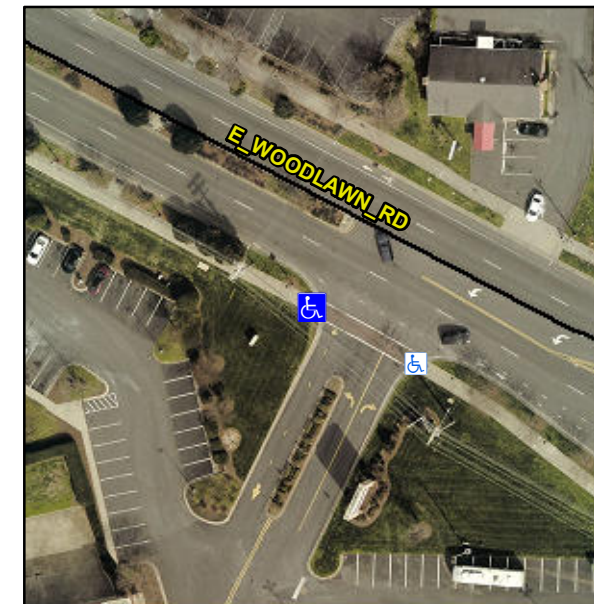
Compliance	Description	Data	Compliance	Description	Data
N/A	Ramp Length (in)	48.0	N/A	Grade Break?	N/A
Yes	Ramp Width (in)	48.0	N/A	Grade Break Slope (%)	0.0
No	Ramp Slope (%)	9.1	N/A	Grade Break XSlope (%)	0.0
Yes	Ramp XSlope (%)	0.2			
N/A	Flare Type LT	N/A	N/A	Flare Type RT	N/A
N/A	Flare Slope LT (%)	N/A	N/A	Flare Slope RT (%)	0.0
N/A	Flare Traversable LT?	N/A	N/A	Flare Traversable RT?	N/A
N/A	Landing Length (in)	0.0	N/A	DWS Provided?	N/A
N/A	Landing Width (in)	0.0	N/A	DWS Contrast?	N/A
N/A	Landing Slope (%)	0.0	N/A	DWS Length (in)	N/A
N/A	Landing X Slope (%)	0.0	N/A	DWS Full Width?	N/A
N/A	Landing Curb? (Y/N)	N/A	N/A	DWS Offset LT (in)	N/A
N/A	Shared Landing?	N/A	N/A	DWS Offset RT (in)	N/A
N/A	Gutter Ponding?	0.0	N/A	Gutter Slope (%)	N/A
N/A	Gutter Lip Ht (in)	0.0	N/A	Gutter X Slope (%)	N/A
N/A	Painted X Walk1?	Yes		Road Slope (%)	0.1
	X Walk 1 Direction	To E		Road X Slope (%)	5.3
	X Walk 1 Width (in)	94.0		Clear Space?	N/A

X Walk 1 Slope (%)	0.1	N/A	Clear Space to XWalk (in)	N/A
	X Walk 1 X Slope (%)	5.3	N/A	Storm Grate/Utility Hazard?	N/A
N/A	Ramp inside XWalk1?	Yes		Storm Grate/Utility Type	
N/A	Any Obstructions?	N/A			N/A
	Obstruction Type		Yes	Surface Condition? (G/P)	Good
			N/A	Curb Slope (%)	3.7

Remove & Replace Entire Ramp.
