Access Compliance Report

Public Rights-of-Way

(Curb Ramps)

| Intersection ID: 29677 | Main Street: CAMERON_CREEK_DR | Cross Street: HUNTINGTON_RIDGE_CT | Location: SE |

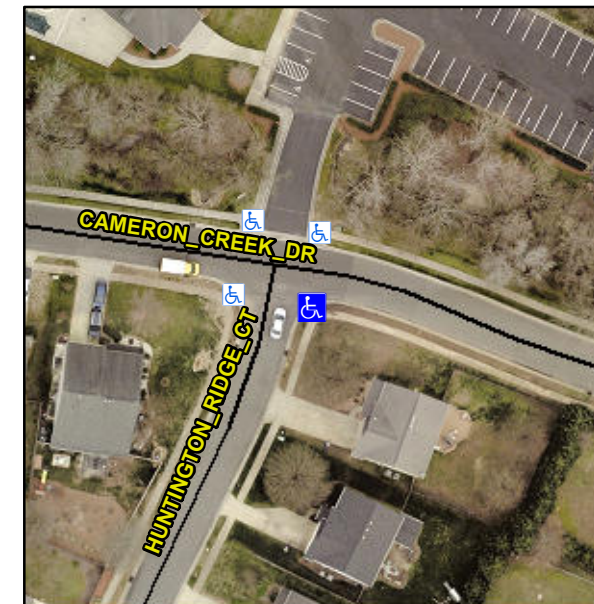
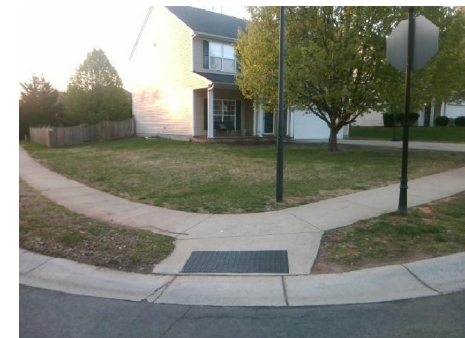
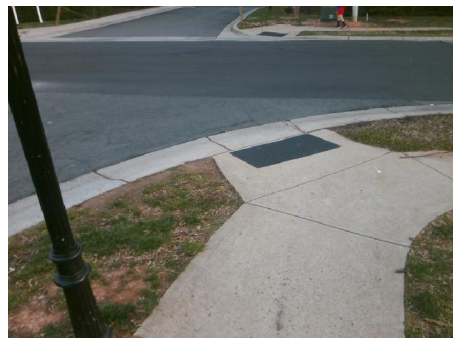
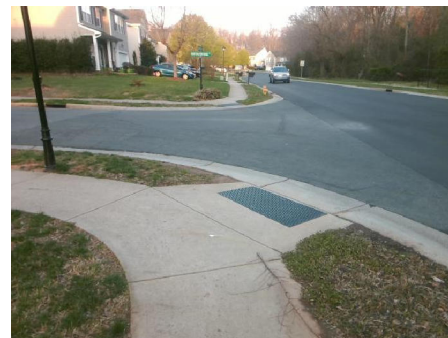
| ADA ID: 2F3763271197 | Ramp Type: BlendTrans1 | Initial Pass/Fail: Fail | Overall Compliance: No |
| | | | Severity Score: 33.75 |

Not Found, R304.5.1, R304.5.3

| Compliance | Description | Data | Compliance | Description | Data |
|---|---|---|---|---|---|
| No | Ramp Width (in) | 45.5 | No | BlendTrans XSlope (%) | 7.0 |

Remove & Replace Curb Ramp With Two New Directional Ramps or Equivalent.
