Access Compliance Report

Public Rights-of-Way

(Curb Ramps)

Intersection ID: 12089	Main Street: E_12TH_ST	Cross Street: N_DAVIDSON_ST	Location: S
ADA ID: 2F37EC3ACA63	Ramp Type: Perp	Initial Pass/Fail: Fail	Overall Compliance: No
		Severity Score: 25

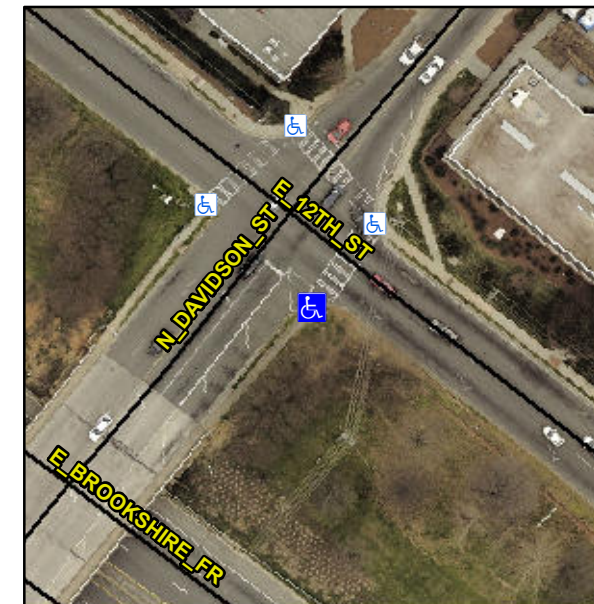
Not Found, R304.5.3

Compliance	Description	Data	Compliance	Description	Data
N/A	Ramp Length (in)	60.0	Yes	Ramp Slope (%)	5.1
Yes	Ramp Width (in)	51.0	No	Ramp XSlope (%)	8.0
N/A	Flare Type LT	N/A	N/A	Flare Type RT	N/A
N/A	Flare Slope LT (%)	N/A	N/A	Flare Slope RT (%)	N/A
N/A	Flare Traversable LT?	N/A	N/A	Flare Traversable RT?	N/A
N/A	Landing Length (in)	N/A	N/A	DWS Provided?	N/A
N/A	Landing Width (in)	N/A	N/A	DWS Contrast?	N/A
N/A	Landing Slope (%)	N/A	N/A	DWS Length (in)	N/A
N/A	Landing X Slope (%)	N/A	N/A	DWS Full Width?	N/A
N/A	Landing Curb? (Y/N)	N/A	N/A	DWS Offset (in)	N/A
N/A	Shared Landing?	N/A			
N/A	Gutter Ponding?	N/A	N/A	Gutter Slope (%)	N/A
N/A	Gutter Lip Ht (in)	0.5	N/A	Gutter X Slope (%)	N/A
N/A	Painted X Walk1?	Yes	N/A	Painted X Walk2?	N/A
	X Walk 1 Direction	To NE		X Walk 2 Direction	N/A
N/A	X Walk 1 Width (in)	143.0	N/A	X Walk 2 Width (in)	N/A
	X Walk 1 Slope (%)	1.2		X Walk 2 Slope (%)	N/A
	X Walk 1 X Slope (%)	10.9		X Walk 2 X Slope (%)	N/A

N/A	Ramp inside XWalk1?	Yes	N/A	Ramp inside XWalk2?	N/A
	Road Slope (%)	N/A	N/A	Clear Space?	N/A
	Road X Slope (%)	N/A	N/A	Clear Space to XWalk (in)	N/A
N/A	Any Obstructions?	N/A	N/A	Storm Grate/Utility Hazard?	N/A
	Obstruction Type			Storm Grate/Utility Type	
		N/A			N/A
		Yes		Surface Condition? (G/P)	Good

Remove & Replace Entire Ramp.

Total Cost: \$ 1850.00
