Access Compliance Report

Public Rights-of-Way

(Curb Ramps)

Intersection ID: 48600	Main Street: GRANDIFLORA_DR	Cross Street: N/A	Location: SE
ADA ID: 2F3AC23333F8	Ramp Type: BlendTrans1	Initial Pass/Fail: Fail	Overall Compliance: No
Severity Score: 10			
Codes/Mitigation Info/Possible Solution		Field Measurements/Component Compliance

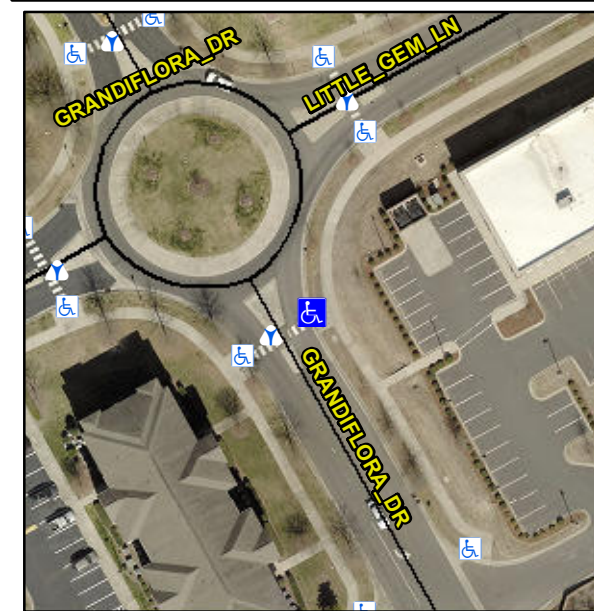
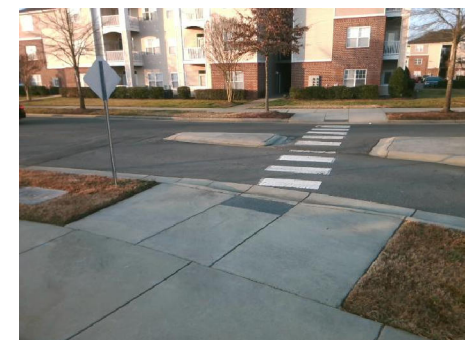
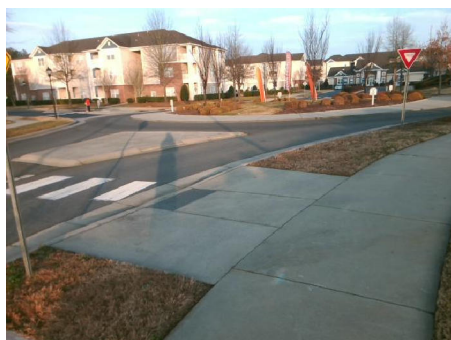
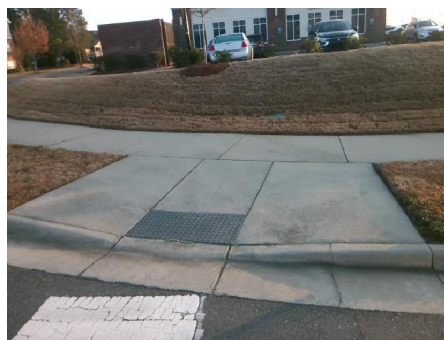
Not Found, R304.5.1, R304.5.3

Compliance	Description	Data	Compliance	Description	Data
N/A	Ramp Length (in)	99.5	Yes	BlendTrans Slope (%)	4.5
No	Ramp Width (in)	47.5	No	BlendTrans XSlope (%)	3.0
N/A	Flare Type LT	N/A	N/A	Flare Type RT	N/A
N/A	Flare Slope LT (%)	N/A	N/A	Flare Slope RT (%)	N/A
N/A	Flare Traversable LT?	N/A	N/A	Flare Traversable RT?	N/A
N/A	Landing Length (in)	N/A	N/A	DWS Provided?	N/A
N/A	Landing Width (in)	N/A	N/A	DWS Contrast?	N/A
N/A	Landing Slope (%)	N/A	N/A	DWS Length (in)	N/A
N/A	Landing X Slope (%)	N/A	N/A	DWS Full Width?	N/A
N/A	Landing Curb? (Y/N)	N/A	N/A	DWS Offset (in)	N/A
N/A	Shared Landing?	N/A			
N/A	Gutter Ponding?	N/A	N/A	Gutter Slope (%)	N/A
N/A	Gutter Lip Ht (in)	N/A	N/A	Gutter X Slope (%)	N/A
N/A	Painted X Walk1?	Yes	N/A	Painted X Walk2?	N/A
	X Walk 1 Direction	To SW		X Walk 2 Direction	N/A
	X Walk 1 Width (in)	49.0		X Walk 2 Width (in)	N/A
	X Walk 1 Slope (%)	1.9		X Walk 2 Slope (%)	N/A
	X Walk 1 X Slope (%)	2.1		X Walk 2 X Slope (%)	N/A

N/A	Ramp inside XWalk1?	Yes	N/A	Ramp inside XWalk2?	N/A
	Road Slope (%)	2.1		Clear Space?	N/A
	Road X Slope (%)	1.9	N/A	Clear Space to XWalk (in)	N/A
N/A	Any Obstructions?	N/A	N/A	Storm Grate/Utility Hazard?	N/A
	Obstruction Type			Storm Grate/Utility Type	
		N/A			N/A
			Yes	Surface Condition? (G/P)	Good
			No	Curb Slope (%)	7.8

Remove & Replace Curb Ramp With Two New Directional Ramps or Equivalent.
