# Access Compliance Report

## Public Rights-of-Way

### (Curb Ramps)

Intersection ID: 3891	Main Street: GLASTON_LN	Cross Street: PARKLEIGH_DR	Location:	W
ADA ID: 2F3D9245A16D	Ramp Type: Perp	Initial Pass/Fail: Fail	Overall Compliance: No	Severity Score: 25

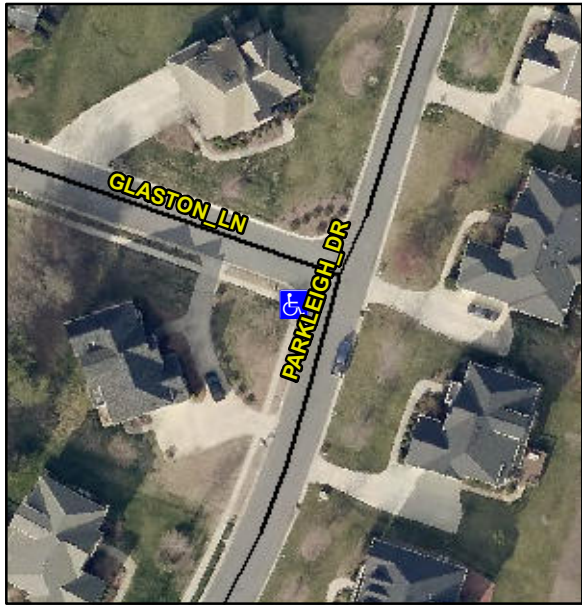
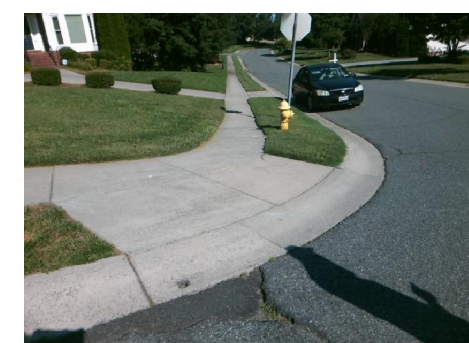
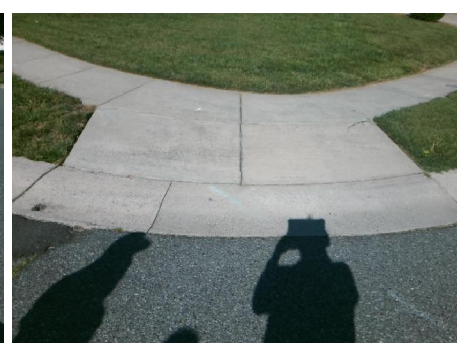
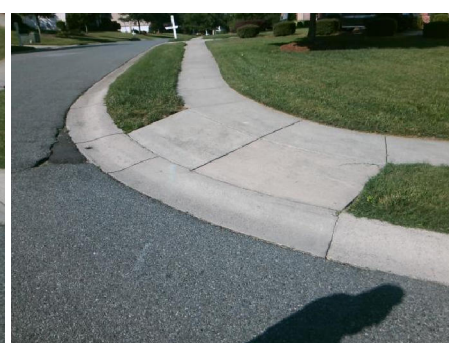
Possible Solutions:		Compliance	Description	Data	Compliance	Description	Data
	Remove & Replace Entire Ramp.		N/A	Ramp Length (in)	47.0	Yes	Ramp Slope (%)	7.0
			Yes	Ramp Width (in)	132.0	No	Ramp XSlope (%)	12.7
			N/A	Flare Type LT	N/A	N/A	Flare Type RT	N/A
			N/A	Flare Slope LT (%)	N/A	N/A	Flare Slope RT (%)	N/A
			N/A	Flare Traversable LT?	N/A	N/A	Flare Traversable RT?	N/A
			N/A	Landing Length (in)	N/A	N/A	DWS Provided?	N/A
			N/A	Landing Width (in)	N/A	N/A	DWS Contrast?	N/A
			N/A	Landing Slope (%)	N/A	N/A	DWS Length (in)	N/A
			N/A	Landing X Slope (%)	N/A	N/A	DWS Full Width?	N/A
Surveyor Notes:		N/A	N/A	Landing Curb? (Y/N)	N/A	N/A	DWS Offset (in)	N/A
PROW/ADA:		Not Found, R304.5.3	N/A	Shared Landing?	N/A			
			N/A	Gutter Ponding?	N/A	N/A	Gutter Slope (%)	N/A
			N/A	Gutter Lip Ht (in)	N/A	N/A	Gutter X Slope (%)	N/A

N/A	Painted X Walk1?	No	N/A	Painted X Walk2?	N/A
				X Walk 1 Direction	To NE		X Walk 2 Direction	N/A
			N/A	X Walk 1 Width (in)	N/A	N/A	X Walk 2 Width (in)	N/A
				X Walk 1 Slope (%)	3.5		X Walk 2 Slope (%)	N/A
				X Walk 1 X Slope (%)	7.0		X Walk 2 X Slope (%)	N/A
			N/A	Ramp inside XWalk1?	N/A	N/A	Ramp inside XWalk2?	N/A
				Road Slope (%)	N/A	N/A	Clear Space?	N/A
				Road X Slope (%)	N/A	N/A	Clear Space to XWalk (in)	N/A
			N/A	Any Obstructions?	N/A	N/A	Storm Grate/Utility Hazard?	N/A
				Obstruction Type			Storm Grate/Utility Type	
					N/A			N/A
						Yes	Surface Condition? (G/P)	Good
