# Access Compliance Report

## Public Rights-of-Way

### (Curb Ramps)

| Intersection ID: 14714 | Main Street: E_MOREHEAD_ST | Cross Street: HARDING_PL | Location: SW |

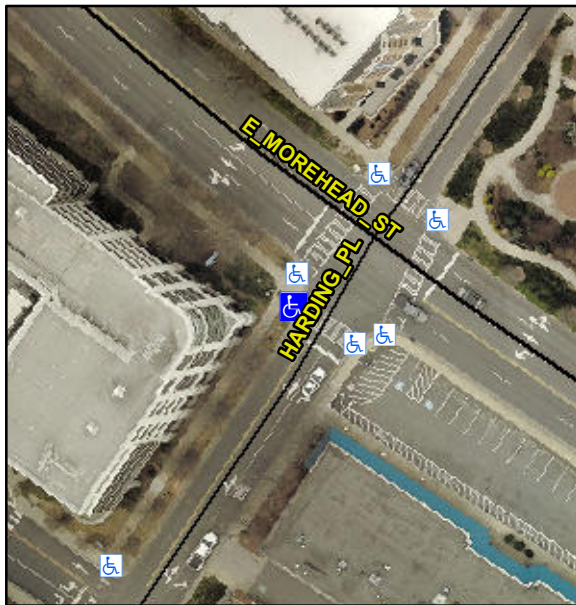
**Not Found, R304.5.3, R304.2.2-Perp,  
R304.3.2-Para, R304.2.3, R305.1.4**

| Compliance | Description | Data | Compliance | Description | Data |
|---|---|---|---|---|---|
| Yes | Ramp Width (in) | 49.0 | No | Ramp XSlope (%) | 2.4 |
| N/A | Flare Slope LT (%) | 3.3 | No | Flare Slope RT (%) | 10.8 |
| No | Landing Slope (%) | 3.7 | Yes | DWS Length (in) | 25.0 |
| No | Landing X Slope (%) | 2.3 | No | DWS Full Width? | No |
| Yes | Gutter Lip Ht (in) | 0.0 | No | Gutter X Slope (%) | 2.1 |

**Remove & Replace Entire Ramp.  
Remove & Replace Gutter.**
