Access Compliance Report

Public Rights-of-Way

(Curb Ramps)

Intersection ID: 54454	Main Street: COLLINGHAM_DR	Cross Street: STEELE_CREEK_RD	Location: SW
ADA ID: 2F4221CBD0E0	Ramp Type: Perp	Initial Pass/Fail: Fail	Overall Compliance: No
		Severity Score: 12.5

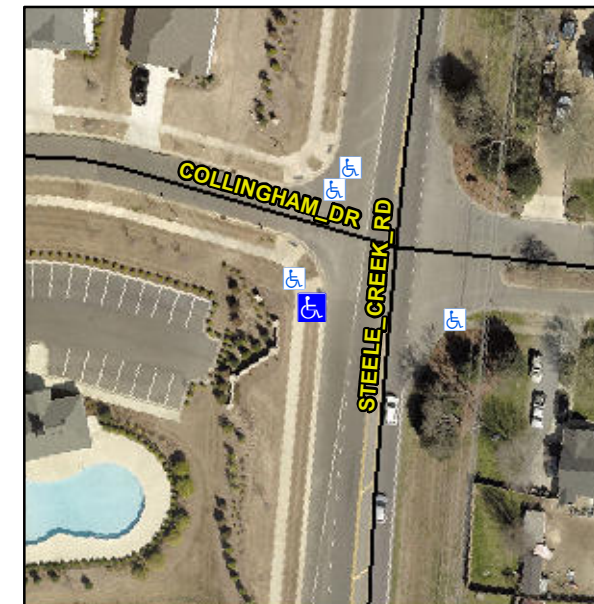
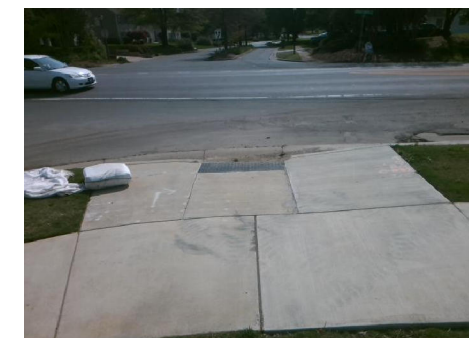
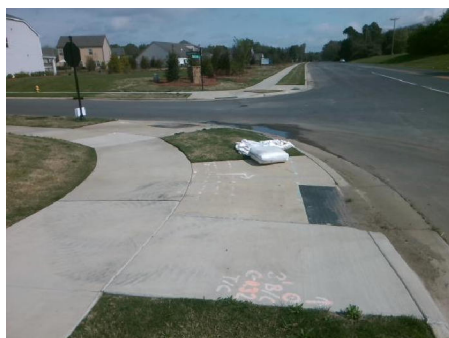
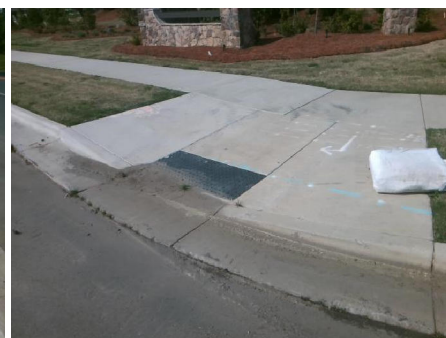
Compliance	Description	Data	Compliance	Description	Data
N/A	Ramp Length (in)	97.0	No	Ramp Slope (%)	8.8
Yes	Ramp Width (in)	57.0	Yes	Ramp XSlope (%)	1.0
N/A	Flare Type LT	N/A	N/A	Flare Type RT	N/A
N/A	Flare Slope LT (%)	N/A	N/A	Flare Slope RT (%)	N/A
N/A	Flare Traversable LT?	N/A	N/A	Flare Traversable RT?	N/A
N/A	Landing Length (in)	N/A	N/A	DWS Provided?	N/A
N/A	Landing Width (in)	N/A	N/A	DWS Contrast?	N/A
N/A	Landing Slope (%)	N/A	N/A	DWS Length (in)	N/A
N/A	Landing X Slope (%)	N/A	N/A	DWS Full Width?	N/A
N/A	Landing Curb? (Y/N)	N/A	N/A	DWS Offset (in)	N/A
N/A	Shared Landing?	N/A			
N/A	Gutter Ponding?	N/A	N/A	Gutter Slope (%)	N/A
N/A	Gutter Lip Ht (in)	1.3	N/A	Gutter X Slope (%)	N/A
N/A	Painted X Walk1?	No	N/A	Painted X Walk2?	N/A
	X Walk 1 Direction	To SE		X Walk 2 Direction	N/A
N/A	X Walk 1 Width (in)	N/A	N/A	X Walk 2 Width (in)	N/A
	X Walk 1 Slope (%)	2.3		X Walk 2 Slope (%)	N/A
	X Walk 1 X Slope (%)	0.0		X Walk 2 X Slope (%)	N/A

N/A	Ramp inside XWalk1?	N/A	N/A	Ramp inside XWalk2?	N/A
	Road Slope (%)	N/A	N/A	Clear Space?	N/A
	Road X Slope (%)	N/A	N/A	Clear Space to XWalk (in)	N/A
N/A	Any Obstructions?	N/A	N/A	Storm Grate/Utility Hazard?	N/A
	Obstruction Type			Storm Grate/Utility Type	
		N/A			N/A
			Yes	Surface Condition? (G/P)	Good

Remove & Replace Entire Ramp.

R304.2.2
