# Access Compliance Report

### (Curb Ramps)

| Intersection ID: 3984 | Main Street: GENOA_LN | Cross Street: HALLIWELL_ST | Location: S |
| ADA ID: 2F4702FD897F | Ramp Type: Perp | Initial Pass/Fail: Fail | Overall Compliance: No |

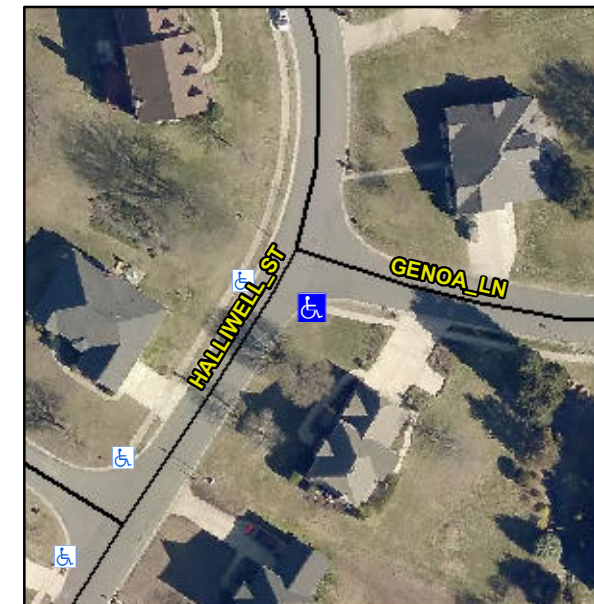
| | | Severity Score: 25 | |

**Not Found, R304.5.3**

| Compliance | Description | Data | Compliance | Description | Data |
|---|---|---|---|---|---|
| N/A | Ramp Length (in) | 42.0 | Yes | Ramp Slope (%) | 7.3 |
| Yes | Ramp Width (in) | 48.0 | No | Ramp XSlope (%) | 11.4 |

**Remove & Replace Entire Ramp.**

Total Cost: \$ 1850.00
