# Access Compliance Report

## Public Rights-of-Way

### (Curb Ramps)

Intersection ID: 10024053	Main Street: CORONATION_BV	Cross Street: N/A	Location: W
ADA ID: 2F48B289423C	Ramp Type: PerpDiag	Initial Pass/Fail: Fail	Overall Compliance: No
		Severity Score: 25

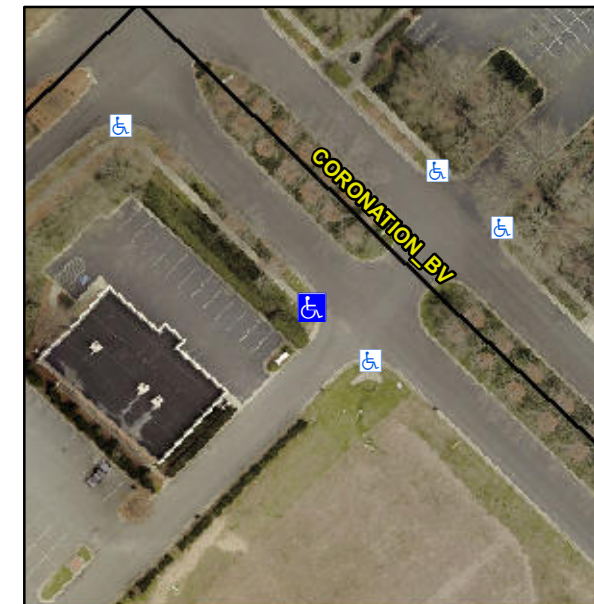
**Not Found, R304.5.3**

Compliance	Description	Data	Compliance	Description	Data
N/A	Ramp Length (in)	68.5	Yes	Ramp Slope (%)	5.8
Yes	Ramp Width (in)	48.0	No	Ramp XSlope (%)	9.5
N/A	Flare Type LT	N/A	N/A	Flare Type RT	N/A
N/A	Flare Slope LT (%)	N/A	N/A	Flare Slope RT (%)	N/A
N/A	Flare Traversable LT?	N/A	N/A	Flare Traversable RT?	N/A
N/A	Landing Length (in)	N/A	N/A	DWS Provided?	N/A
N/A	Landing Width (in)	N/A	N/A	DWS Contrast?	N/A
N/A	Landing Slope (%)	N/A	N/A	DWS Length (in)	N/A
N/A	Landing X Slope (%)	N/A	N/A	DWS Full Width?	N/A
N/A	Landing Curb? (Y/N)	N/A	N/A	DWS Offset (in)	N/A
N/A	Shared Landing?	N/A			
N/A	Gutter Ponding?	N/A	N/A	Gutter Slope (%)	N/A
N/A	Gutter Lip Ht (in)	N/A	N/A	Gutter X Slope (%)	N/A
N/A	Painted X Walk1?	No	N/A	Painted X Walk2?	No
	X Walk 1 Direction	To SE		X Walk 2 Direction	To NE
N/A	X Walk 1 Width (in)	N/A	N/A	X Walk 2 Width (in)	N/A
	X Walk 1 Slope (%)	1.3		X Walk 2 Slope (%)	3.5
	X Walk 1 X Slope (%)	9.8		X Walk 2 X Slope (%)	1.6

N/A	Ramp inside XWalk1?	N/A	N/A	Ramp inside XWalk2?	N/A
	Road Slope (%)	9.2	N/A	Clear Space?	N/A
	Road X Slope (%)	7.6	N/A	Clear Space to XWalk (in)	N/A
N/A	Any Obstructions?	N/A	N/A	Storm Grate/Utility Hazard?	N/A
	Obstruction Type			Storm Grate/Utility Type	
		N/A			N/A
			Yes	Surface Condition? (G/P)	Good

**Remove & Replace Curb Ramp With Two New Directional Ramps or Equivalent.**
