Access Compliance Report

Public Rights-of-Way

(Curb Ramps)

Intersection ID: 4264	Main Street: MT_HOLLY-HUNTERSVILLE_RD	Cross Street: OVERLOOK_MOUNTAIN_DR	Location: NW
ADA ID: 2F52C63A75E2	Ramp Type: Perp	Initial Pass/Fail: Fail	Overall Compliance: No
Codes/Mitigation Info/Possible Solution		Field Measurements/Component Compliance	
Severity Score: 26.25

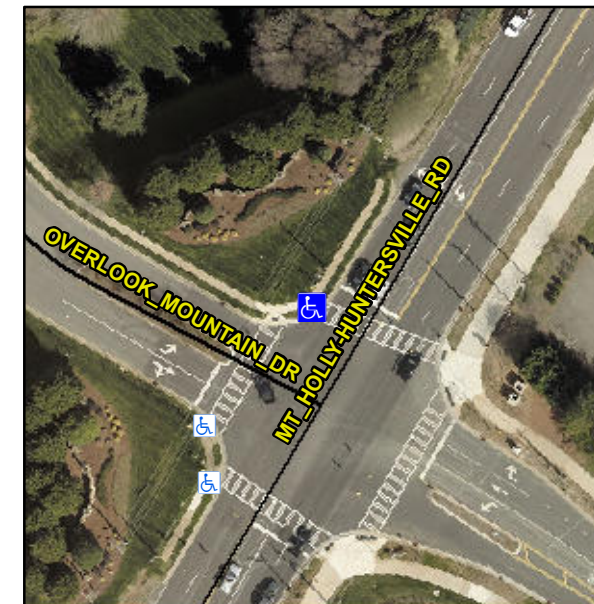
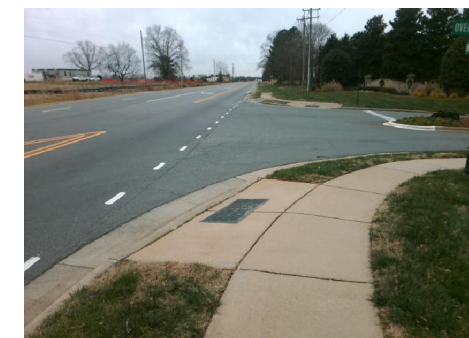
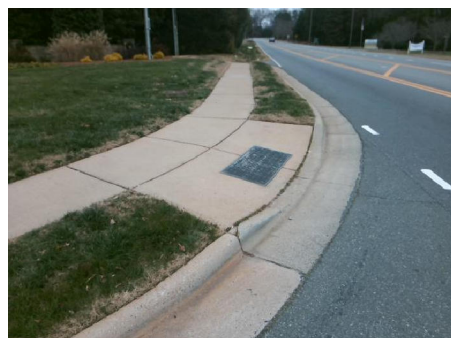
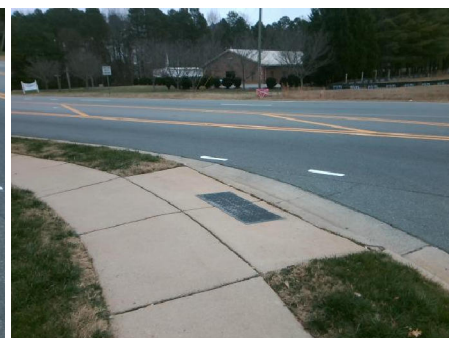
Compliance	Description	Data	Compliance	Description	Data
N/A	Ramp Length (in)	51.0	No	Ramp Slope (%)	12.7
Yes	Ramp Width (in)	48.0	No	Ramp XSlope (%)	2.2
N/A	Flare Type LT	N/A	N/A	Flare Type RT	N/A
N/A	Flare Slope LT (%)	N/A	N/A	Flare Slope RT (%)	N/A
N/A	Flare Traversable LT?	N/A	N/A	Flare Traversable RT?	N/A
N/A	Landing Length (in)	N/A	N/A	DWS Provided?	N/A
N/A	Landing Width (in)	N/A	N/A	DWS Contrast?	N/A
N/A	Landing Slope (%)	N/A	N/A	DWS Length (in)	N/A
N/A	Landing X Slope (%)	N/A	N/A	DWS Full Width?	N/A
N/A	Landing Curb? (Y/N)	N/A	N/A	DWS Offset (in)	N/A
N/A	Shared Landing?	N/A			
N/A	Gutter Ponding?	N/A	N/A	Gutter Slope (%)	N/A
N/A	Gutter Lip Ht (in)	N/A	N/A	Gutter X Slope (%)	N/A
N/A	Painted X Walk1?	No	N/A	Painted X Walk2?	N/A
	X Walk 1 Direction	To SW		X Walk 2 Direction	N/A
N/A	X Walk 1 Width (in)	N/A	N/A	X Walk 2 Width (in)	N/A
	X Walk 1 Slope (%)	1.3		X Walk 2 Slope (%)	N/A
	X Walk 1 X Slope (%)	3.2		X Walk 2 X Slope (%)	N/A

N/A	Ramp inside XWalk1?	N/A	N/A	Ramp inside XWalk2?	N/A
	Road Slope (%)	N/A	N/A	Clear Space?	N/A
	Road X Slope (%)	N/A	N/A	Clear Space to XWalk (in)	N/A
N/A	Any Obstructions?	N/A	N/A	Storm Grate/Utility Hazard?	N/A
	Obstruction Type			Storm Grate/Utility Type	
		N/A			N/A
			Yes	Surface Condition? (G/P)	Good

Possible Solutions:

Remove & Replace Entire Ramp.

PROW/ADA:

R304.2.2, R304.5.3
