Access Compliance Report

Public Rights-of-Way

(Curb Ramps)

Intersection ID: 15094	Main Street: ALBEMARLE_RD	Cross Street: REDDMAN_RD	Location: NE
ADA ID: 2F562371ABED	Ramp Type: Perp	Initial Pass/Fail: Fail	Overall Compliance: No
Severity Score: 33.75			
Codes/Mitigation Info/Possible Solution		Field Measurements/Component Compliance

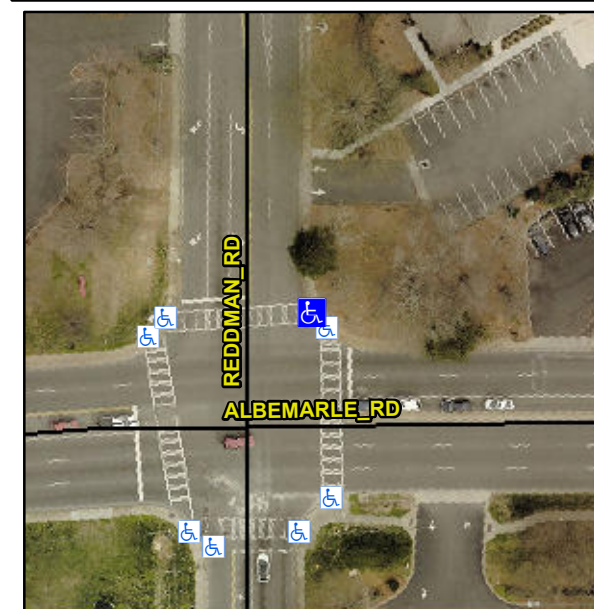
Not Found, R304.5.1, R304.2.2, R304.5.3

Compliance	Description	Data	Compliance	Description	Data
N/A	Ramp Length (in)	60.0	No	Ramp Slope (%)	10.2
No	Ramp Width (in)	40.0	No	Ramp XSlope (%)	5.4
N/A	Flare Type LT	N/A	N/A	Flare Type RT	N/A
N/A	Flare Slope LT (%)	N/A	N/A	Flare Slope RT (%)	N/A
N/A	Flare Traversable LT?	N/A	N/A	Flare Traversable RT?	N/A
N/A	Landing Length (in)	N/A	N/A	DWS Provided?	N/A
N/A	Landing Width (in)	N/A	N/A	DWS Contrast?	N/A
N/A	Landing Slope (%)	N/A	N/A	DWS Length (in)	N/A
N/A	Landing X Slope (%)	N/A	N/A	DWS Full Width?	N/A
N/A	Landing Curb? (Y/N)	N/A	N/A	DWS Offset (in)	N/A
N/A	Shared Landing?	N/A			
N/A	Gutter Ponding?	N/A	N/A	Gutter Slope (%)	N/A
N/A	Gutter Lip Ht (in)	N/A	N/A	Gutter X Slope (%)	N/A
N/A	Painted X Walk1?	Yes	N/A	Painted X Walk2?	N/A
	X Walk 1 Direction	To W		X Walk 2 Direction	N/A
N/A	X Walk 1 Width (in)	110.0	N/A	X Walk 2 Width (in)	N/A
	X Walk 1 Slope (%)	4.5		X Walk 2 Slope (%)	N/A
	X Walk 1 X Slope (%)	3.7		X Walk 2 X Slope (%)	N/A

N/A	Ramp inside XWalk1?	Yes	N/A	Ramp inside XWalk2?	N/A
	Road Slope (%)	N/A	N/A	Clear Space?	N/A
	Road X Slope (%)	N/A	N/A	Clear Space to XWalk (in)	N/A
N/A	Any Obstructions?	N/A	N/A	Storm Grate/Utility Hazard?	N/A
	Obstruction Type			Storm Grate/Utility Type	
		N/A			N/A
		Yes		Surface Condition? (G/P)	Good

Remove & Replace Entire Ramp.
