Access Compliance Report Public Rights-of-Way (Curb Ramps)

Intersection ID: 10029210Main Street: JOHN_PRICE_RDCross Street: N/ALocation:SWADA ID: 2F6FE137304FRamp Type: PerpInitial Pass/Fail: FailOverall Compliance: NoSeverity Score:25

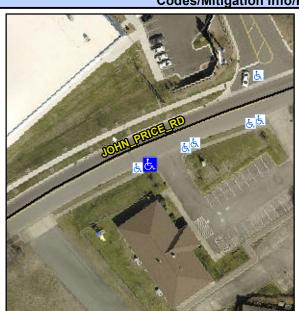
Comp	liance Description	Data		liance Description	Data
N/A	Ramp Length (in)	40.0	Yes	Ramp Slope (%)	6.5
Yes	Ramp Width (in)	48.0	No	Ramp XSlope (%)	7.3
N/A	Flare Type LT	N/A	N/A	Flare Type RT	N/A
N/A	Flare Slope LT (%)	N/A	N/A	Flare Slope RT (%)	N/A
N/A	Flare Traversable LT?	N/A	N/A	Flare Traversable RT?	N/A
N/A	Landing Length (in)	N/A	N/A	DWS Provided?	N/A
N/A	Landing Width (in)	N/A	N/A	DWS Contrast?	N/A
N/A	Landing Slope (%)	N/A	N/A	DWS Length (in)	N/A
N/A	Landing X Slope (%)	N/A	N/A	DWS Full Width?	N/A
N/A	Landing Curb? (Y/N)	N/A	N/A	DWS Offset (in)	N/A
N/A	Shared Landing?	N/A			
N/A	Gutter Ponding?	N/A	N/A	Gutter Slope (%)	N/A
N/A	Gutter Lip Ht (in)	N/A	N/A	Gutter X Slope (%)	N/A
N/A	Painted X Walk1?	No	N/A	Painted X Walk2?	N/A
	X Walk 1 Direction	To E		X Walk 2 Direction	N/A
N/A	X Walk 1 Width (in)	N/A	N/A	X Walk 2 Width (in)	N/A
	X Walk 1 Slope (%)	2.0		X Walk 2 Slope (%)	N/A
	X Walk 1 X Slope (%)	8.3		X Walk 2 X Slope (%)	N/A

N/A	Ramp inside XWalk1?	N/A	N/A	Ramp inside XWalk2?	N/A
	Road Slope (%)	N/A	N/A	Clear Space?	N/A
	Road X Slope (%)	N/A	N/A	Clear Space to XWalk (in)	N/A
N/A	Any Obstructions?	N/A	N/A	Storm Grate/Utility Hazard?	N/A
	Obstruction Type			Storm Grate/Utility Type	
		N/A			N/A
			Yes	Surface Condition? (G/P)	Good
	The state of the s

rossible solution	
Possible Solutions:	Com
Remove & Replace Entire Ramp.	N/A
	Yes
	N/A
	N/A
	N/A
	N/A
Surveyor Notes:	N/A
N/A	N/A
	N/A
	N/A
	N/A
PROW/ADA:	N/A
Not Found, R304.5.3	N/A
	N/A
	N/A
	N/A
