Access Compliance Report

Public Rights-of-Way

(Curb Ramps)

Intersection ID: 27245	Main Street: ELMSTONE_DR	Cross Street: THORNCREST_RD	Location: SE
ADA ID: 2F7C40E42701	Ramp Type: PerpDiag	Initial Pass/Fail: Fail	Overall Compliance: No
		Severity Score: 22.5

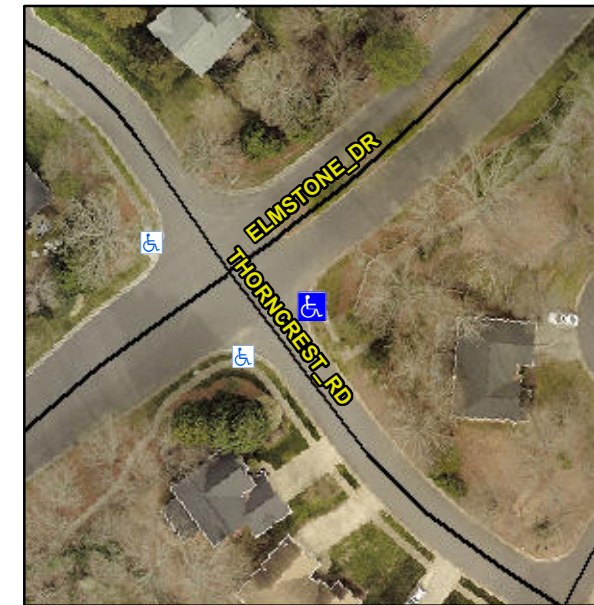
Compliance	Description	Data	Compliance	Description	Data
N/A	Ramp Length (in)	93.0	No	Ramp Slope (%)	8.9
No	Ramp Width (in)	47.0	No	Ramp XSlope (%)	3.9
N/A	Flare Type LT	N/A	N/A	Flare Type RT	N/A
N/A	Flare Slope LT (%)	N/A	N/A	Flare Slope RT (%)	N/A
N/A	Flare Traversable LT?	N/A	N/A	Flare Traversable RT?	N/A
N/A	Landing Length (in)	N/A	N/A	DWS Provided?	N/A
N/A	Landing Width (in)	N/A	N/A	DWS Contrast?	N/A
N/A	Landing Slope (%)	N/A	N/A	DWS Length (in)	N/A
N/A	Landing X Slope (%)	N/A	N/A	DWS Full Width?	N/A
N/A	Landing Curb? (Y/N)	N/A	N/A	DWS Offset (in)	N/A
N/A	Shared Landing?	N/A			
N/A	Gutter Ponding?	N/A	N/A	Gutter Slope (%)	N/A
N/A	Gutter Lip Ht (in)	N/A	N/A	Gutter X Slope (%)	N/A
N/A	Painted X Walk1?	No	N/A	Painted X Walk2?	No
	X Walk 1 Direction	To NW		X Walk 2 Direction	To SW
N/A	X Walk 1 Width (in)	N/A	N/A	X Walk 2 Width (in)	N/A
	X Walk 1 Slope (%)	0.3		X Walk 2 Slope (%)	0.6
	X Walk 1 X Slope (%)	1.3		X Walk 2 X Slope (%)	5.2

N/A	Ramp inside XWalk1?	N/A	N/A	Ramp inside XWalk2?	N/A
	Road Slope (%)	1.4	N/A	Clear Space?	N/A
	Road X Slope (%)	0.1	N/A	Clear Space to XWalk (in)	N/A
N/A	Any Obstructions?	N/A	N/A	Storm Grate/Utility Hazard?	N/A
	Obstruction Type			Storm Grate/Utility Type	
		N/A			N/A
			Yes	Surface Condition? (G/P)	Good

Remove & Replace Curb Ramp With Two New Directional Ramps or Equivalent.

R304.5.1, R304.2.2, R304.5.3
