Access Compliance Report

Public Rights-of-Way

(Curb Ramps)

Intersection ID: N/A	Main Street: BACK_CREEK_DR	Cross Street: UNIVERSITY_EAST_DR	Location: NE
ADA ID: 2F7CD0B1BA19	Ramp Type: Combination2Diag	Initial Pass/Fail: Fail	Overall Compliance: No
Severity Score: 0			
Codes/Mitigation Info/Possible Solution		Field Measurements/Component Compliance

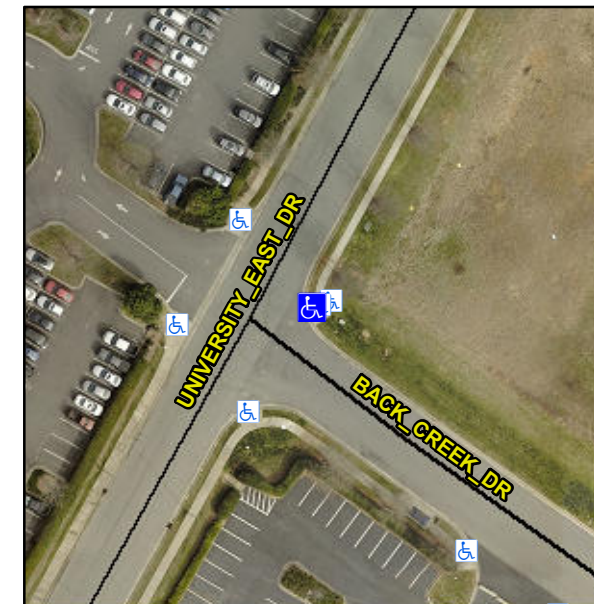
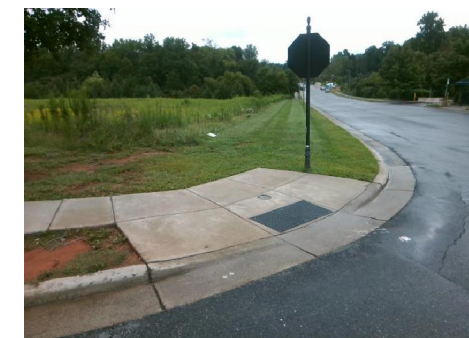
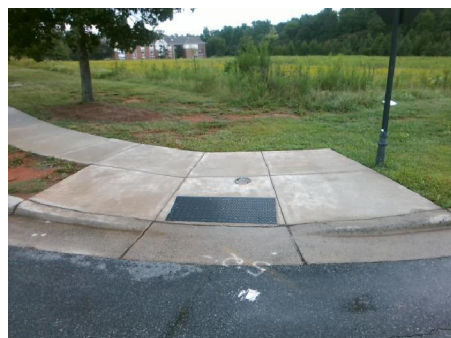
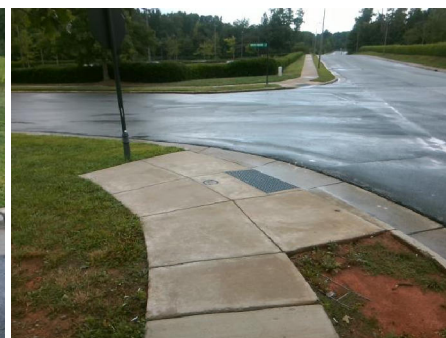
Compliance	Description	Data	Compliance	Description	Data
N/A	Ramp Length LT (in)	48.0	N/A	Ramp Length RT (in)	48.0
No	Ramp Width LT (in)	47.5	No	Ramp Width RT (in)	47.0
No	Ramp Slope LT (%)	9.6	Yes	Ramp Slope RT (%)	1.8
Yes	Ramp XSlope LT (%)	0.2	No	Ramp XSlope RT (%)	3.0
N/A	Ramp Length (in)	47.0	Yes	Ramp Slope (%)	7.6
No	Ramp Width (in)	46.0	No	Ramp XSlope (%)	2.8
N/A	Flare Type LT	N/A	N/A	Flare Type RT	N/A
N/A	Flare Slope LT (%)	N/A	N/A	Flare Slope RT (%)	N/A
N/A	Flare Traversable LT?	N/A	N/A	Flare Traversable RT?	N/A
N/A	Landing Length (in)	N/A	N/A	DWS Provided?	N/A
N/A	Landing Width (in)	N/A	N/A	DWS Contrast?	N/A
N/A	Landing Slope (%)	N/A	N/A	DWS Length (in)	N/A
N/A	Landing X Slope (%)	N/A	N/A	DWS Full Width?	N/A
N/A	Landing Curb? (Y/N)	N/A	N/A	DWS Offset (in)	N/A
N/A	Shared Landing?	N/A			
N/A	Gutter Ponding?	N/A	N/A	Gutter Slope (%)	N/A
N/A	Gutter Lip Ht (in)	N/A	N/A	Gutter X Slope (%)	N/A
N/A	Painted X Walk1?	No	N/A	Painted X Walk2?	No

X Walk 1 Direction	To W		X Walk 2 Direction	To S
	X Walk 1 Width (in)	N/A		X Walk 2 Width (in)	N/A
	X Walk 1 Slope (%)	3.8		X Walk 2 Slope (%)	0.9
	X Walk 1 X Slope (%)	3.7		X Walk 2 X Slope (%)	4.4
N/A	Ramp inside XWalk1?	N/A	N/A	Ramp inside XWalk2?	N/A
	Road Slope (%)	3.2		Clear Space?	N/A
	Road X Slope (%)	0.7	N/A	Clear Space to XWalk (in)	N/A
			N/A	Any Obstruction?	N/A
				Obstruction Type	N/A
			N/A	Storm Grate/Utility Hazard?	N/A
				Storm Grate/Utility Type	N/A
Yes	Surface Condition? (G/P)	Good			
	Curb Slope (%)	2.0

Remove & Replace Curb Ramp With Two New Directional Ramps or Equivalent.
