Access Compliance Report

Public Rights-of-Way

(Curb Ramps)

Intersection ID: 10025384	Main Street: E_9TH_ST	Cross Street: N/A	Location: NE
ADA ID: 2F822CA6366F	Ramp Type: BlendTrans1	Initial Pass/Fail: Fail	Overall Compliance: No
Severity Score: 8.75			
Codes/Mitigation Info/Possible Solution		Field Measurements/Component Compliance

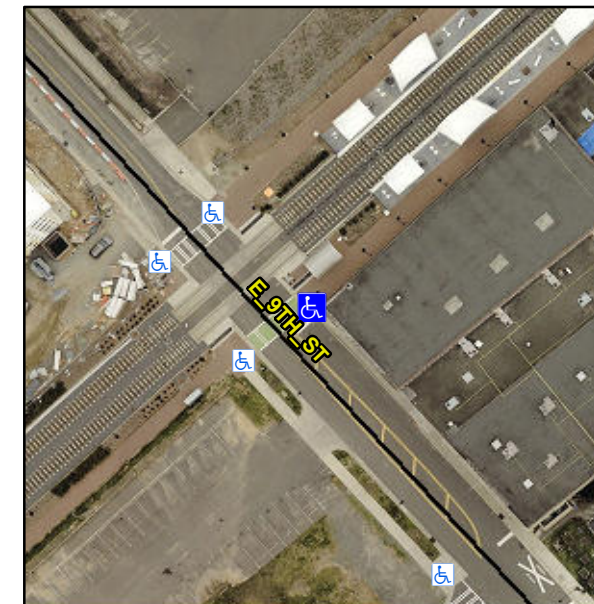
Not Found, R304.5.1

Compliance	Description	Data	Compliance	Description	Data
N/A	Ramp Length (in)	66.5	Yes	BlendTrans Slope (%)	1.5
No	Ramp Width (in)	47.0	Yes	BlendTrans XSlope (%)	1.7
N/A	Flare Type LT	N/A	N/A	Flare Type RT	N/A
N/A	Flare Slope LT (%)	N/A	N/A	Flare Slope RT (%)	N/A
N/A	Flare Traversable LT?	N/A	N/A	Flare Traversable RT?	N/A
N/A	Landing Length (in)	N/A	N/A	DWS Provided?	N/A
N/A	Landing Width (in)	N/A	N/A	DWS Contrast?	N/A
N/A	Landing Slope (%)	N/A	N/A	DWS Length (in)	N/A
N/A	Landing X Slope (%)	N/A	N/A	DWS Full Width?	N/A
N/A	Landing Curb? (Y/N)	N/A	N/A	DWS Offset (in)	N/A
N/A	Shared Landing?	N/A			
N/A	Gutter Ponding?	N/A	N/A	Gutter Slope (%)	N/A
N/A	Gutter Lip Ht (in)	N/A	N/A	Gutter X Slope (%)	N/A
N/A	Painted X Walk1?	Yes	N/A	Painted X Walk2?	N/A
	X Walk 1 Direction	To SW		X Walk 2 Direction	N/A
	X Walk 1 Width (in)	111.0		X Walk 2 Width (in)	N/A
	X Walk 1 Slope (%)	2.1		X Walk 2 Slope (%)	N/A
	X Walk 1 X Slope (%)	1.3		X Walk 2 X Slope (%)	N/A

N/A	Ramp inside XWalk1?	Yes	N/A	Ramp inside XWalk2?	N/A
	Road Slope (%)	1.3		Clear Space?	N/A
	Road X Slope (%)	2.1	N/A	Clear Space to XWalk (in)	N/A
N/A	Any Obstructions?	N/A	N/A	Storm Grate/Utility Hazard?	N/A
	Obstruction Type			Storm Grate/Utility Type	
		N/A			N/A
			Yes	Surface Condition? (G/P)	Good
			No	Curb Slope (%)	8.3

Possible Solutions:

Remove & Replace Curb Ramp With Two New Directional Ramps or Equivalent.
