Intersection ID: 3530	Main Street: KIMMEL_LN	Cross Street: TREYBURN_DR	Location:	N
ADA ID: 2F85C7C47A01	Ramp Type: Perp	Initial Pass/Fail: Fail	Overall Compliance: No	Severity Score: 13.75

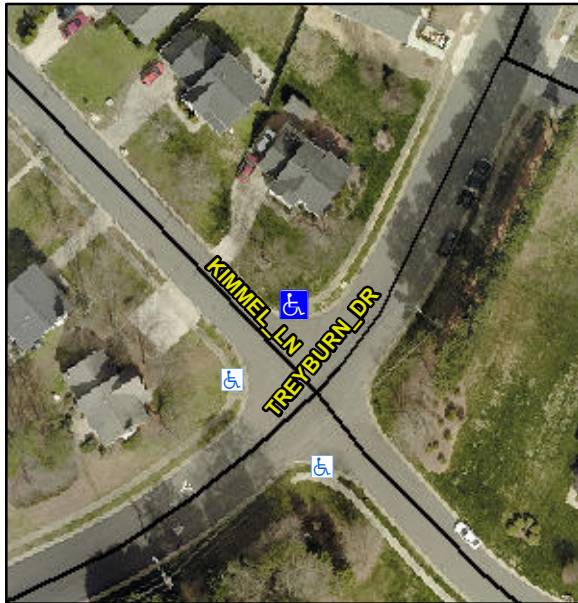
Not Found, R304.2.2, R304.5.3

Compliance	Description	Data	Compliance	Description	Data
N/A	Ramp Length (in)	97.0	No	Ramp Slope (%)	10.3
Yes	Ramp Width (in)	48.0	No	Ramp XSlope (%)	4.2
N/A	Flare Type LT	N/A	N/A	Flare Type RT	N/A
N/A	Flare Slope LT (%)	N/A	N/A	Flare Slope RT (%)	N/A
N/A	Flare Traversable LT?	N/A	N/A	Flare Traversable RT?	N/A
N/A	Landing Length (in)	N/A	N/A	DWS Provided?	N/A
N/A	Landing Width (in)	N/A	N/A	DWS Contrast?	N/A
N/A	Landing Slope (%)	N/A	N/A	DWS Length (in)	N/A
N/A	Landing X Slope (%)	N/A	N/A	DWS Full Width?	N/A
N/A	Landing Curb? (Y/N)	N/A	N/A	DWS Offset (in)	N/A
N/A	Shared Landing?	N/A			
N/A	Gutter Ponding?	N/A	N/A	Gutter Slope (%)	N/A
N/A	Gutter Lip Ht (in)	N/A	N/A	Gutter X Slope (%)	N/A
N/A	Painted X Walk1?	No	N/A	Painted X Walk2?	N/A
	X Walk 1 Direction	To SW		X Walk 2 Direction	N/A
N/A	X Walk 1 Width (in)	N/A	N/A	X Walk 2 Width (in)	N/A
	X Walk 1 Slope (%)	1.2		X Walk 2 Slope (%)	N/A
	X Walk 1 X Slope (%)	0.8		X Walk 2 X Slope (%)	N/A

N/A	Ramp inside XWalk1?	N/A	N/A	Ramp inside XWalk2?	N/A
	Road Slope (%)	N/A	N/A	Clear Space?	N/A
	Road X Slope (%)	N/A	N/A	Clear Space to XWalk (in)	N/A
N/A	Any Obstructions?	N/A	N/A	Storm Grate/Utility Hazard?	N/A
	Obstruction Type			Storm Grate/Utility Type	
		N/A			N/A
			Yes	Surface Condition? (G/P)	Good

Remove & Replace Entire Ramp.
