Access Compliance Report

Public Rights-of-Way

(Curb Ramps)

Intersection ID: 2549	Main Street: BEARDSLEY_DR	Cross Street: MCCHESENEY_DR	Location: S
ADA ID: 2F86D129ECA	Ramp Type: PerpDiag	Initial Pass/Fail: Fail	Overall Compliance: No
Severity Score: 12.5

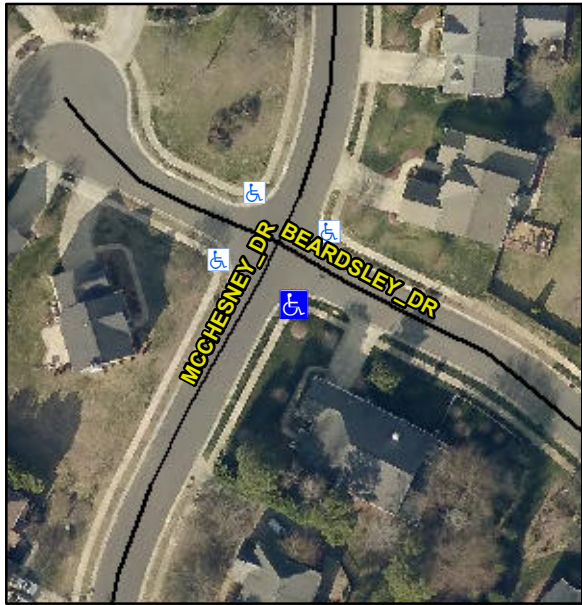
Possible Solutions:		Compliance	Description	Data	Compliance	Description	Data
	Remove & Replace Curb Ramp With Two New Directional Ramps or Equivalent.		N/A	Ramp Length (in)	48.5	Yes	Ramp Slope (%)	5.3
			Yes	Ramp Width (in)	48.0	No	Ramp XSlope (%)	6.2
			N/A	Flare Type LT	N/A	N/A	Flare Type RT	N/A
			N/A	Flare Slope LT (%)	N/A	N/A	Flare Slope RT (%)	N/A
			N/A	Flare Traversable LT?	N/A	N/A	Flare Traversable RT?	N/A
	Surveyor Notes:		N/A	Landing Length (in)	N/A	N/A	DWS Provided?	N/A
			N/A	Landing Width (in)	N/A	N/A	DWS Contrast?	N/A
			N/A	Landing Slope (%)	N/A	N/A	DWS Length (in)	N/A
			N/A	Landing X Slope (%)	N/A	N/A	DWS Full Width?	N/A
N/A			Landing Curb? (Y/N)	N/A	N/A	DWS Offset (in)	N/A	
PROW/ADA:		N/A	Shared Landing?	N/A				
Not Found, R304.5.3		N/A	Gutter Ponding?	N/A	N/A	Gutter Slope (%)	N/A	
		N/A	Gutter Lip Ht (in)	N/A	N/A	Gutter X Slope (%)	N/A

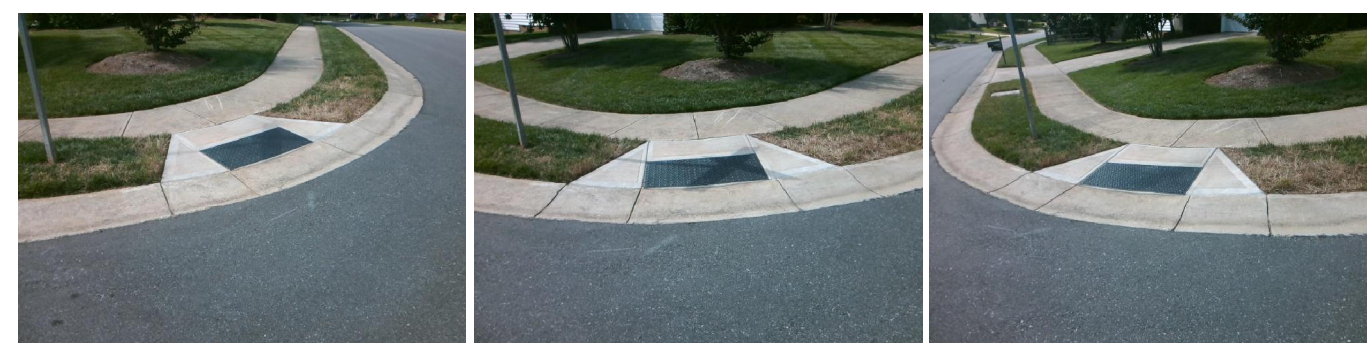
N/A	Painted X Walk1?	No	N/A	Painted X Walk2?	No	
			X Walk 1 Direction	To NE		X Walk 2 Direction	To NW	
		N/A	X Walk 1 Width (in)	N/A	N/A	X Walk 2 Width (in)	N/A	
			X Walk 1 Slope (%)	0.2		X Walk 2 Slope (%)	5.5	
			X Walk 1 X Slope (%)	2.4		X Walk 2 X Slope (%)	1.5	
		N/A	Ramp inside XWalk1?	N/A	N/A	Ramp inside XWalk2?	N/A	
			Road Slope (%)	4.6	N/A	Clear Space?	N/A	
			Road X Slope (%)	2.7	N/A	Clear Space to XWalk (in)	N/A	
		N/A	Any Obstructions?	N/A	N/A	Storm Grate/Utility Hazard?	N/A	
			Obstruction Type			Storm Grate/Utility Type		
				N/A			N/A	
					Yes	Surface Condition? (G/P)	Good	
Total Cost:		\$	3200.00
