Access Compliance Report

Public Rights-of-Way

(Curb Ramps)

Intersection ID: N/A	Main Street: E_19TH_ST	Cross Street: PEGRAM_ST	Location: W
ADA ID: 2F8D04F82AF2	Ramp Type: Combination1Diag	Initial Pass/Fail: Fail	Overall Compliance: No
		Severity Score: 0

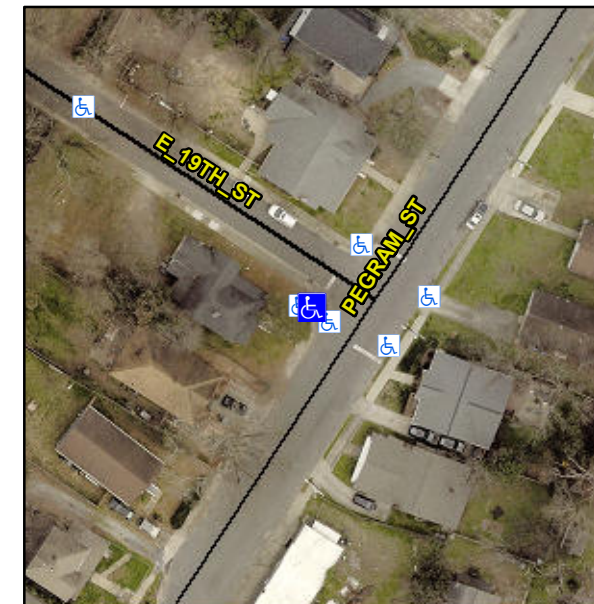
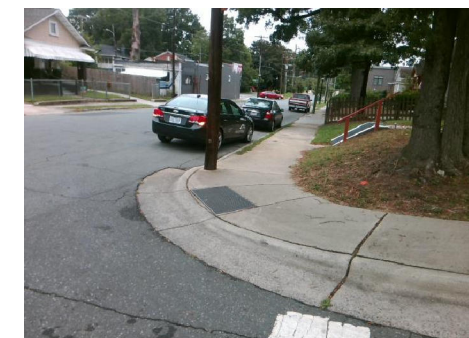
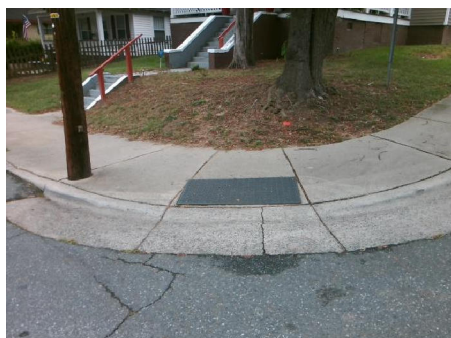
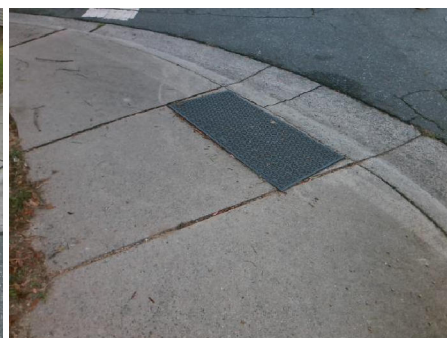
Not Found, R304.5.1, R304.5.1, R304.5.3, R304.3.2

Compliance	Description	Data	Compliance	Description	Data
N/A	Ramp Length LT (in)	28.0	N/A	Ramp Length RT (in)	50.0
No	Ramp Width LT (in)	42.0	No	Ramp Width RT (in)	41.5
Yes	Ramp Slope LT (%)	6.4	No	Ramp Slope RT (%)	13.4
No	Ramp XSlope LT (%)	2.6	No	Ramp XSlope RT (%)	5.2
N/A	Ramp Length (in)	25.5	Yes	Ramp Slope (%)	1.0
No	Ramp Width (in)	47.0	No	Ramp XSlope (%)	5.9
N/A	Flare Type LT	N/A	N/A	Flare Type RT	N/A
N/A	Flare Slope LT (%)	N/A	N/A	Flare Slope RT (%)	N/A
N/A	Flare Traversable LT?	N/A	N/A	Flare Traversable RT?	N/A
N/A	Landing Length (in)	N/A	N/A	DWS Provided?	N/A
N/A	Landing Width (in)	N/A	N/A	DWS Contrast?	N/A
N/A	Landing Slope (%)	N/A	N/A	DWS Length (in)	N/A
N/A	Landing X Slope (%)	N/A	N/A	DWS Full Width?	N/A
N/A	Landing Curb? (Y/N)	N/A	N/A	DWS Offset (in)	N/A
N/A	Shared Landing?	N/A			
N/A	Gutter Ponding?	N/A	N/A	Gutter Slope (%)	N/A
N/A	Gutter Lip Ht (in)	N/A	N/A	Gutter X Slope (%)	N/A
N/A	Painted X Walk1?	No	N/A	Painted X Walk2?	No

X Walk 1 Direction	To SE		X Walk 2 Direction	To NE
	X Walk 1 Width (in)	N/A		X Walk 2 Width (in)	N/A
	X Walk 1 Slope (%)	2.2		X Walk 2 Slope (%)	7.0
	X Walk 1 X Slope (%)	3.0		X Walk 2 X Slope (%)	1.3
N/A	Ramp inside XWalk1?	N/A	N/A	Ramp inside XWalk2?	N/A
	Road Slope (%)	1.0		Clear Space?	N/A
	Road X Slope (%)	6.3	N/A	Clear Space to XWalk (in)	N/A
			N/A	Any Obstruction?	N/A
				Obstruction Type	N/A
			N/A	Storm Grate/Utility Hazard?	N/A
				Storm Grate/Utility Type	N/A
			Yes	Surface Condition? (G/P)	Good
				Curb Slope (%)	14.6

Remove & Replace Curb Ramp With Two New Directional Ramps or Equivalent.
