Access Compliance Report

Public Rights-of-Way

(Curb Ramps)

Intersection ID: 29139	Main Street: BALSAM_TREE_DR	Cross Street: STONEY_VALLEY_CT	Location: NW
ADA ID: 2F92E981E05B	Ramp Type: BlendTrans1	Initial Pass/Fail: Fail	Overall Compliance: No
Severity Score: 25			
Codes/Mitigation Info/Possible Solution		Field Measurements/Component Compliance

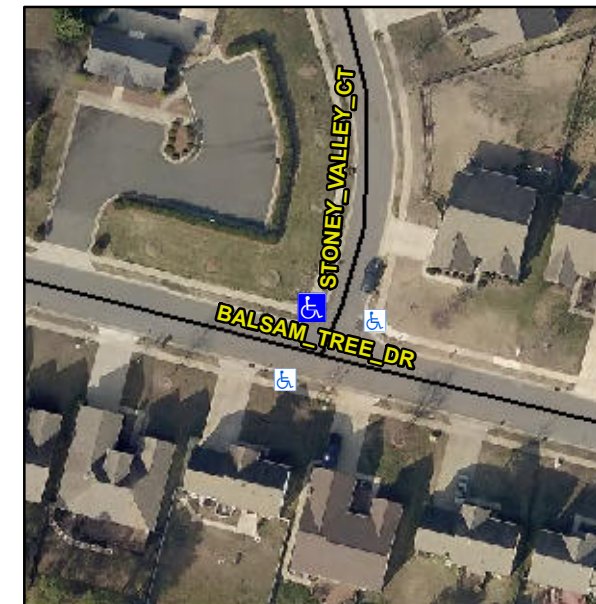
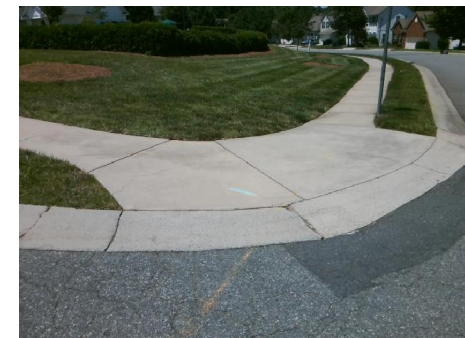
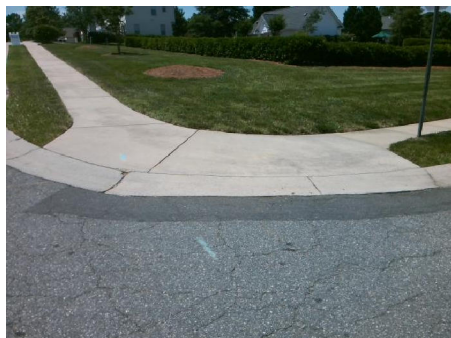
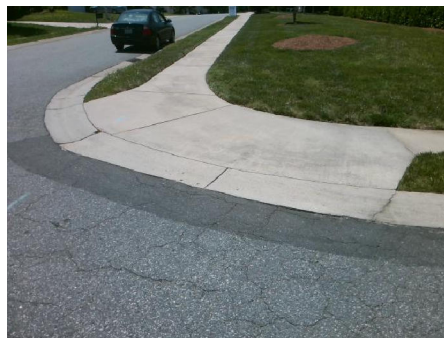
Not Found, R304.5.3

Compliance	Description	Data	Compliance	Description	Data
N/A	Ramp Length (in)	49.0	Yes	BlendTrans Slope (%)	0.1
Yes	Ramp Width (in)	224.0	No	BlendTrans XSlope (%)	10.6
N/A	Flare Type LT	N/A	N/A	Flare Type RT	N/A
N/A	Flare Slope LT (%)	N/A	N/A	Flare Slope RT (%)	N/A
N/A	Flare Traversable LT?	N/A	N/A	Flare Traversable RT?	N/A
N/A	Landing Length (in)	N/A	N/A	DWS Provided?	N/A
N/A	Landing Width (in)	N/A	N/A	DWS Contrast?	N/A
N/A	Landing Slope (%)	N/A	N/A	DWS Length (in)	N/A
N/A	Landing X Slope (%)	N/A	N/A	DWS Full Width?	N/A
N/A	Landing Curb? (Y/N)	N/A	N/A	DWS Offset (in)	N/A
N/A	Shared Landing?	N/A			
N/A	Gutter Ponding?	N/A	N/A	Gutter Slope (%)	N/A
N/A	Gutter Lip Ht (in)	N/A	N/A	Gutter X Slope (%)	N/A
N/A	Painted X Walk1?	No	N/A	Painted X Walk2?	No
	X Walk 1 Direction	To SE		X Walk 2 Direction	To E
	X Walk 1 Width (in)	N/A		X Walk 2 Width (in)	N/A
	X Walk 1 Slope (%)	3.9		X Walk 2 Slope (%)	4.0
	X Walk 1 X Slope (%)	4.8		X Walk 2 X Slope (%)	5.1

N/A	Ramp inside XWalk1?	N/A	N/A	Ramp inside XWalk2?	N/A
	Road Slope (%)	5.3		Clear Space?	N/A
	Road X Slope (%)	0.7	N/A	Clear Space to XWalk (in)	N/A
N/A	Any Obstructions?	N/A	N/A	Storm Grate/Utility Hazard?	N/A
	Obstruction Type			Storm Grate/Utility Type	
		N/A			N/A
			Yes	Surface Condition? (G/P)	Good
			No	Curb Slope (%)	8.5

Remove & Replace Curb Ramp With Two New Directional Ramps or Equivalent.

Total Cost: \$ 3200.00
