Access Compliance Report

Public Rights-of-Way

(Curb Ramps)

Intersection ID: 29647	Main Street: BALLYSHANNON_LN	Cross Street: SOUTHERN_GARDEN_LN	Location: NE
ADA ID: 2F94BD736330	Ramp Type: PerpDiag	Initial Pass/Fail: Fail	Overall Compliance: No
Severity Score: 8.75			
Codes/Mitigation Info/Possible Solution		Field Measurements/Component Compliance

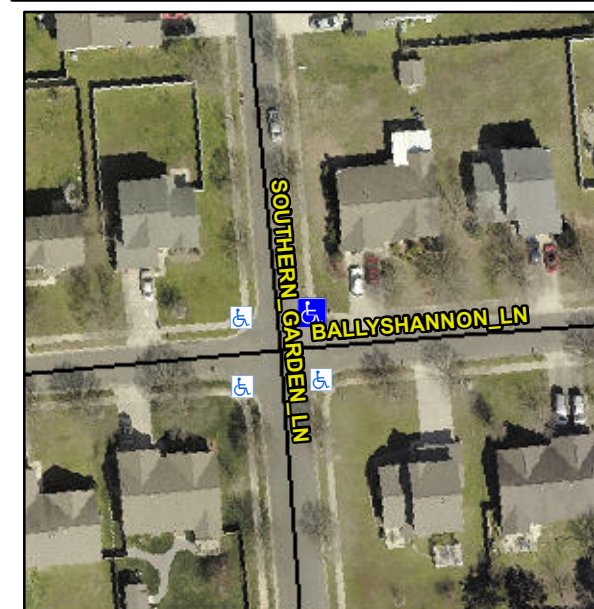
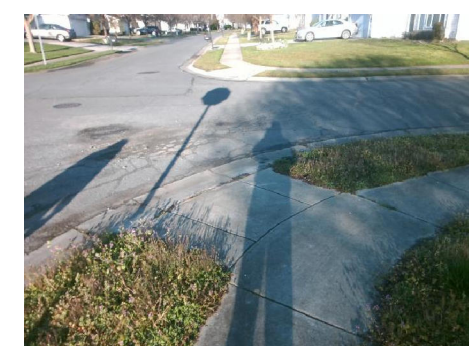
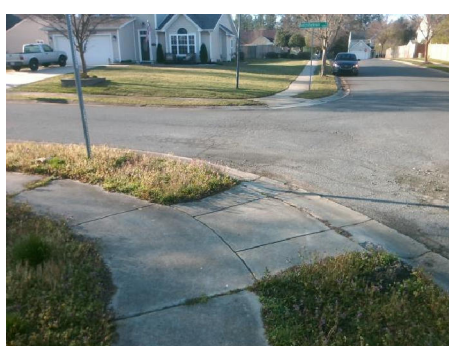
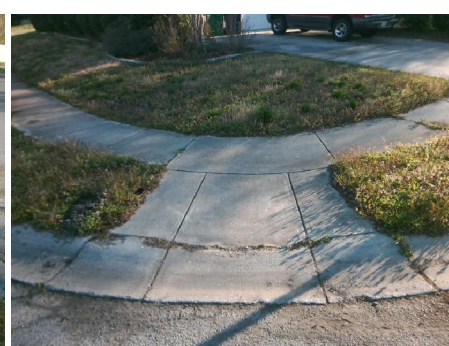
Not Found, R304.5.1

Compliance	Description	Data	Compliance	Description	Data
N/A	Ramp Length (in)	49.0	Yes	Ramp Slope (%)	7.4
No	Ramp Width (in)	36.0	Yes	Ramp XSlope (%)	0.1
N/A	Flare Type LT	N/A	N/A	Flare Type RT	N/A
N/A	Flare Slope LT (%)	N/A	N/A	Flare Slope RT (%)	N/A
N/A	Flare Traversable LT?	N/A	N/A	Flare Traversable RT?	N/A
N/A	Landing Length (in)	N/A	N/A	DWS Provided?	N/A
N/A	Landing Width (in)	N/A	N/A	DWS Contrast?	N/A
N/A	Landing Slope (%)	N/A	N/A	DWS Length (in)	N/A
N/A	Landing X Slope (%)	N/A	N/A	DWS Full Width?	N/A
N/A	Landing Curb? (Y/N)	N/A	N/A	DWS Offset (in)	N/A
N/A	Shared Landing?	N/A			
N/A	Gutter Ponding?	N/A	N/A	Gutter Slope (%)	N/A
N/A	Gutter Lip Ht (in)	N/A	N/A	Gutter X Slope (%)	N/A
N/A	Painted X Walk1?	No	N/A	Painted X Walk2?	No
	X Walk 1 Direction	To W		X Walk 2 Direction	To S
N/A	X Walk 1 Width (in)	N/A	N/A	X Walk 2 Width (in)	N/A
	X Walk 1 Slope (%)	4.3		X Walk 2 Slope (%)	3.6
	X Walk 1 X Slope (%)	1.6		X Walk 2 X Slope (%)	0.4

N/A	Ramp inside XWalk1?	N/A	N/A	Ramp inside XWalk2?	N/A
	Road Slope (%)	1.0	N/A	Clear Space?	N/A
	Road X Slope (%)	3.8	N/A	Clear Space to XWalk (in)	N/A
N/A	Any Obstructions?	N/A	N/A	Storm Grate/Utility Hazard?	N/A
	Obstruction Type			Storm Grate/Utility Type	
		N/A			N/A
			Yes	Surface Condition? (G/P)	Good

Remove & Replace Curb Ramp With Two New Directional Ramps or Equivalent.

Total Cost: \$ 3200.00
