# Access Compliance Report

## Public Rights-of-Way

### (Curb Ramps)

| Intersection ID: 45310 | Main Street: BENFIELD_RD | Cross Street: RIDGE_RD | Location: NE |

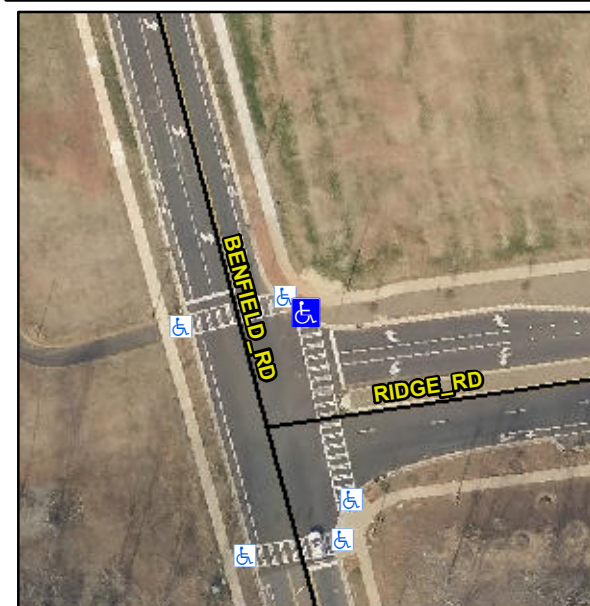
**R304.5.3**

| Compliance | Description | Data | Compliance | Description | Data |
|---|---|---|---|---|---|
| No | Landing X Slope (%) | 2.6 | Yes | DWS Full Width? | Yes |
| Yes | Gutter Lip Ht (in) | 0.0 | No | Gutter X Slope (%) | 2.7 |

**Remove & Replace Landing.  
Remove & Replace Gutter.**
