Access Compliance Report

Public Rights-of-Way

(Curb Ramps)

| Intersection ID: 28291 | Main Street: COMMUNITY HOUSE RD | Cross Street: ARDREY KELL RD | Location: N |

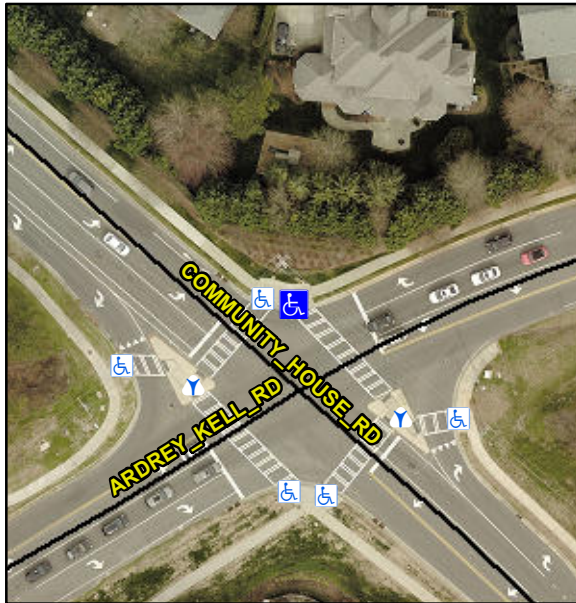
| ADA ID: 2FACD147A1C6 | Ramp Type: Para | Initial Pass/Fail: Fail | Overall Compliance: No |
| Severity Score: 13.75 | | | |

R304.5.3, R304.3.2

| Compliance | Description | Data | Compliance | Description | Data |
|---|---|---|---|---|---|
| Yes | Ramp Slope LT (%) | 6.5 | No | Ramp Slope RT (%) | 9.0 |
| No | Ramp XSlope LT (%) | 4.2 | Yes | Ramp XSlope RT (%) | 1.0 |

Remove & Replace Entire Ramp.
