Access Compliance Report

Public Rights-of-Way

(Curb Ramps)

Intersection ID: 10855	Main Street: WHITING_AV	Cross Street: HOLT_ST	Location: SW
ADA ID: 2FAE7325D23C	Ramp Type: Perp	Initial Pass/Fail: Fail	Overall Compliance: No
Severity Score: 8.75			
Codes/Mitigation Info/Possible Solution		Field Measurements/Component Compliance

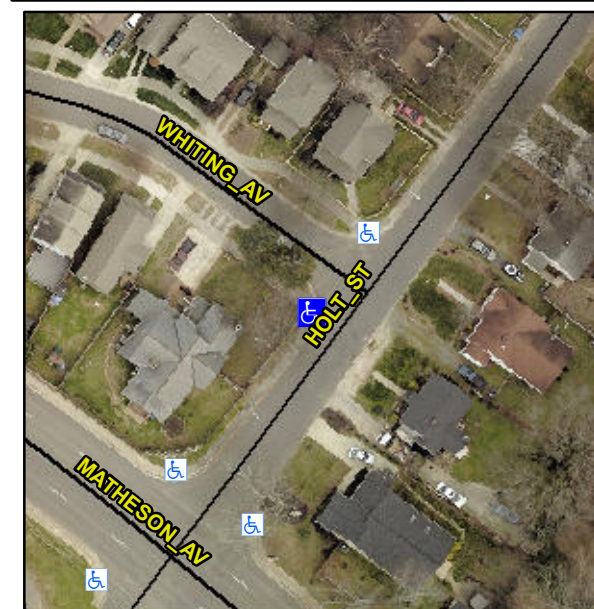
Not Found, R304.5.1

Compliance	Description	Data	Compliance	Description	Data
N/A	Ramp Length (in)	109.0	Yes	Ramp Slope (%)	5.3
No	Ramp Width (in)	45.0	Yes	Ramp XSlope (%)	1.0
N/A	Flare Type LT	N/A	N/A	Flare Type RT	N/A
N/A	Flare Slope LT (%)	N/A	N/A	Flare Slope RT (%)	N/A
N/A	Flare Traversable LT?	N/A	N/A	Flare Traversable RT?	N/A
N/A	Landing Length (in)	N/A	N/A	DWS Provided?	N/A
N/A	Landing Width (in)	N/A	N/A	DWS Contrast?	N/A
N/A	Landing Slope (%)	N/A	N/A	DWS Length (in)	N/A
N/A	Landing X Slope (%)	N/A	N/A	DWS Full Width?	N/A
N/A	Landing Curb? (Y/N)	N/A	N/A	DWS Offset (in)	N/A
N/A	Shared Landing?	N/A			
N/A	Gutter Ponding?	N/A	N/A	Gutter Slope (%)	N/A
N/A	Gutter Lip Ht (in)	0.5	N/A	Gutter X Slope (%)	N/A
N/A	Painted X Walk1?	No	N/A	Painted X Walk2?	N/A
	X Walk 1 Direction	To NE		X Walk 2 Direction	N/A
N/A	X Walk 1 Width (in)	N/A	N/A	X Walk 2 Width (in)	N/A
	X Walk 1 Slope (%)	2.8		X Walk 2 Slope (%)	N/A
	X Walk 1 X Slope (%)	2.8		X Walk 2 X Slope (%)	N/A

N/A	Ramp inside XWalk1?	N/A	N/A	Ramp inside XWalk2?	N/A
	Road Slope (%)	N/A	N/A	Clear Space?	N/A
	Road X Slope (%)	N/A	N/A	Clear Space to XWalk (in)	N/A
N/A	Any Obstructions?	N/A	N/A	Storm Grate/Utility Hazard?	N/A
	Obstruction Type			Storm Grate/Utility Type	
		N/A			N/A
		Yes		Surface Condition? (G/P)	Good

Remove & Replace Entire Ramp.
