# Access Compliance Report

## Public Rights-of-Way

### (Curb Ramps)

Intersection ID: 16186	Main Street: POINDEXTER_DR	Cross Street: WINDSOR_AV	Location: E
ADA ID: 2FB4F25B6690	Ramp Type: Directional1	Initial Pass/Fail: Fail	Overall Compliance: No
		Severity Score: 10

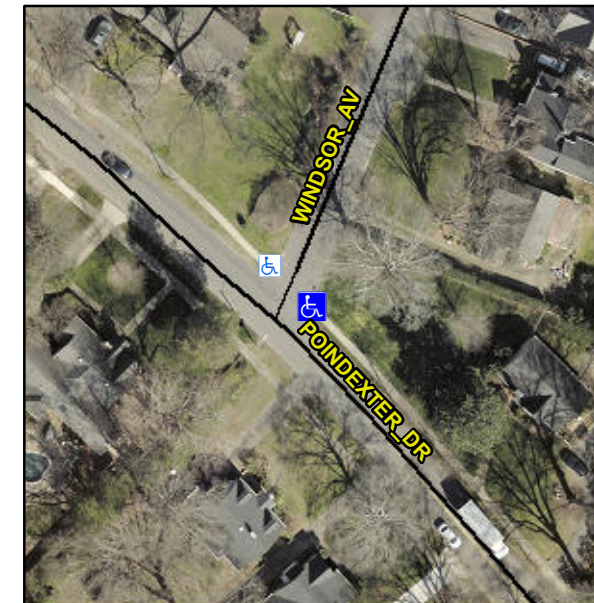
**ASP CURB**

**R304.5.1, R304.5.3**

Compliance	Description	Data	Compliance	Description	Data
N/A	Ramp Length (in)	60.0	N/A	Grade Break?	N/A
No	Ramp Width (in)	46.0	N/A	Grade Break Slope (%)	0.0
Yes	Ramp Slope (%)	7.2	N/A	Grade Break XSlope (%)	0.0
No	Ramp XSlope (%)	3.5			
N/A	Flare Type LT	N/A	N/A	Flare Type RT	N/A
N/A	Flare Slope LT (%)	N/A	N/A	Flare Slope RT (%)	0.0
N/A	Flare Traversable LT?	N/A	N/A	Flare Traversable RT?	N/A
N/A	Landing Length (in)	0.0	N/A	DWS Provided?	N/A
N/A	Landing Width (in)	0.0	N/A	DWS Contrast?	N/A
N/A	Landing Slope (%)	0.0	N/A	DWS Length (in)	N/A
N/A	Landing X Slope (%)	0.0	N/A	DWS Full Width?	N/A
N/A	Landing Curb? (Y/N)	N/A	N/A	DWS Offset LT (in)	N/A
N/A	Shared Landing?	N/A	N/A	DWS Offset RT (in)	N/A
N/A	Gutter Ponding?	0.0	N/A	Gutter Slope (%)	N/A
N/A	Gutter Lip Ht (in)	0.0	N/A	Gutter X Slope (%)	N/A
N/A	Painted X Walk1?	No		Road Slope (%)	1.3
	X Walk 1 Direction	To NW		Road X Slope (%)	6.1
	X Walk 1 Width (in)	N/A		Clear Space?	N/A

X Walk 1 Slope (%)	1.3	N/A	Clear Space to XWalk (in)	N/A
	X Walk 1 X Slope (%)	6.1	N/A	Storm Grate/Utility Hazard?	N/A
N/A	Ramp inside XWalk1?	N/A		Storm Grate/Utility Type	
N/A	Any Obstructions?	N/A			N/A
	Obstruction Type		Yes	Surface Condition? (G/P)	Good
			N/A	Curb Slope (%)	4.6

**Remove & Replace Entire Ramp.**
