Access Compliance Report

Public Rights-of-Way

(Curb Ramps)

Intersection ID: 27855	Main Street: LUNDIN_LINKS_LN	Cross Street: PINE_VALLEY_CLUB_DR	Location: NE
ADA ID: 2FB90D22D7D3	Ramp Type: Perp	Initial Pass/Fail: Pass	Overall Compliance: No
		Severity Score: 10

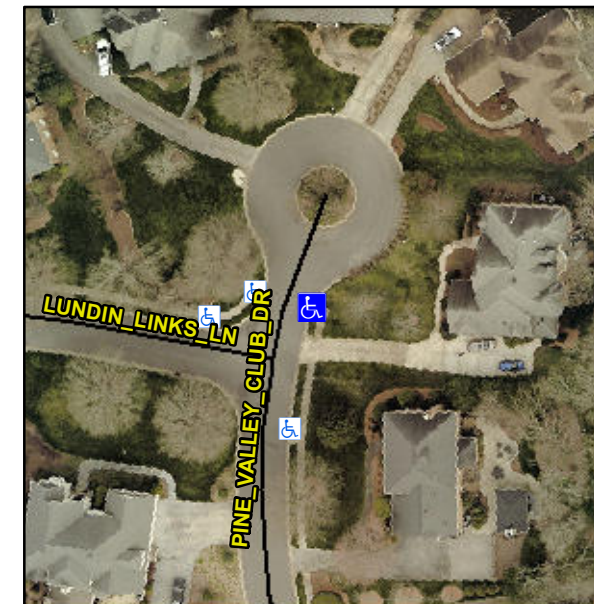
Not Found, R304.2.1, R304.2.2-Perp, R304.3.2-Para, R304.5.3

Compliance	Description	Data	Compliance	Description	Data
N/A	Ramp Length (in)	94.0	Yes	Ramp Slope (%)	6.4
Yes	Ramp Width (in)	48.0	Yes	Ramp XSlope (%)	0.5
N/A	Flare Type LT	Sloped	N/A	Flare Type RT	N/A
N/A	Flare Slope LT (%)	5.7	Yes	Flare Slope RT (%)	4.3
N/A	Flare Traversable LT?	No	N/A	Flare Traversable RT?	Yes
No	Landing Length (in)	N/A	Yes	DWS Provided?	Yes
No	Landing Width (in)	N/A	Yes	DWS Contrast?	Yes
No	Landing Slope (%)	N/A	Yes	DWS Length (in)	24.0
No	Landing X Slope (%)	N/A	Yes	DWS Full Width?	Yes
N/A	Landing Curb? (Y/N)	No	Yes	DWS Offset (in)	1.0
N/A	Shared Landing?	No			
Yes	Gutter Ponding?	No	Yes	Gutter Slope (%)	1.4
Yes	Gutter Lip Ht (in)	0.0	Yes	Gutter X Slope (%)	1.4
N/A	Painted X Walk1?	No	N/A	Painted X Walk2?	N/A
	X Walk 1 Direction	To NW		X Walk 2 Direction	N/A
N/A	X Walk 1 Width (in)	N/A	N/A	X Walk 2 Width (in)	N/A
	X Walk 1 Slope (%)	2.6		X Walk 2 Slope (%)	N/A
	X Walk 1 X Slope (%)	0.8		X Walk 2 X Slope (%)	N/A

N/A	Ramp inside XWalk1?	N/A	N/A	Ramp inside XWalk2?	N/A
	Road Slope (%)	N/A	N/A	Clear Space?	Yes
	Road X Slope (%)	N/A	N/A	Clear Space to XWalk (in)	N/A
Yes	Any Obstructions?	No	Yes	Storm Grate/Utility Hazard?	No
	Obstruction Type			Storm Grate/Utility Type	
		N/A			N/A
			Yes	Surface Condition? (G/P)	Good

Remove & Replace Entire Ramp.
