Access Compliance Report

Public Rights-of-Way

(Curb Ramps)

Intersection ID: 13905	Main Street: CENTRAL_AV	Cross Street: SHERIDAN_DR	Location: SW
ADA ID: 2FBDE8CBAF21	Ramp Type: BlendTrans1	Initial Pass/Fail: Fail	Overall Compliance: No
Severity Score: 30			
Codes/Mitigation Info/Possible Solution		Field Measurements/Component Compliance

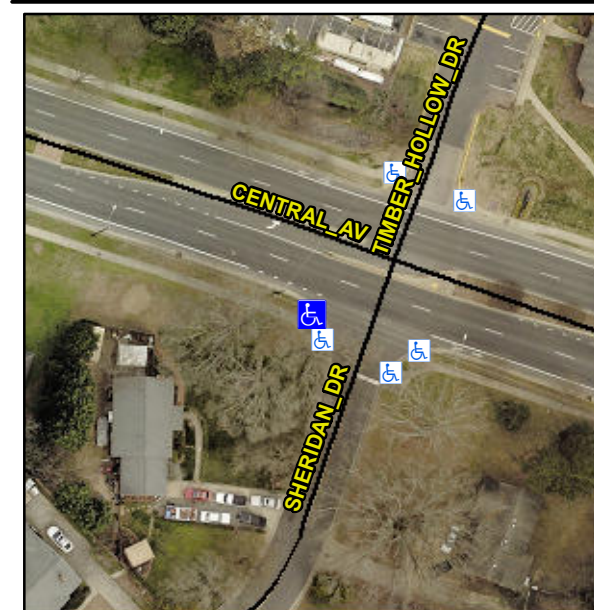
Not Found, R304.5.1, R304.5.3

Compliance	Description	Data	Compliance	Description	Data
N/A	Ramp Length (in)	89.0	Yes	BlendTrans Slope (%)	4.2
No	Ramp Width (in)	32.5	No	BlendTrans XSlope (%)	5.6
N/A	Flare Type LT	N/A	N/A	Flare Type RT	N/A
N/A	Flare Slope LT (%)	N/A	N/A	Flare Slope RT (%)	N/A
N/A	Flare Traversable LT?	N/A	N/A	Flare Traversable RT?	N/A
N/A	Landing Length (in)	N/A	N/A	DWS Provided?	N/A
N/A	Landing Width (in)	N/A	N/A	DWS Contrast?	N/A
N/A	Landing Slope (%)	N/A	N/A	DWS Length (in)	N/A
N/A	Landing X Slope (%)	N/A	N/A	DWS Full Width?	N/A
N/A	Landing Curb? (Y/N)	N/A	N/A	DWS Offset (in)	N/A
N/A	Shared Landing?	N/A			
N/A	Gutter Ponding?	N/A	N/A	Gutter Slope (%)	N/A
N/A	Gutter Lip Ht (in)	N/A	N/A	Gutter X Slope (%)	N/A
N/A	Painted X Walk1?	No	N/A	Painted X Walk2?	N/A
	X Walk 1 Direction	To N		X Walk 2 Direction	N/A
	X Walk 1 Width (in)	N/A		X Walk 2 Width (in)	N/A
	X Walk 1 Slope (%)	5.9		X Walk 2 Slope (%)	N/A
	X Walk 1 X Slope (%)	0.7		X Walk 2 X Slope (%)	N/A

N/A	Ramp inside XWalk1?	N/A	N/A	Ramp inside XWalk2?	N/A
	Road Slope (%)	0.7		Clear Space?	N/A
	Road X Slope (%)	5.9	N/A	Clear Space to XWalk (in)	N/A
N/A	Any Obstructions?	N/A	N/A	Storm Grate/Utility Hazard?	N/A
	Obstruction Type			Storm Grate/Utility Type	
		N/A			N/A
			Yes	Surface Condition? (G/P)	Good
			No	Curb Slope (%)	17.8

Remove & Replace Curb Ramp With Two New Directional Ramps or Equivalent.
