Access Compliance Report

Public Rights-of-Way

(Curb Ramps)

Intersection ID: 13960	Main Street: CENTRAL_AV	Cross Street: KILBORNE_DR	Location: SE
ADA ID: 2FD221FFCBB1	Ramp Type: Para	Initial Pass/Fail: Fail	Overall Compliance: No
		Severity Score: 12.5

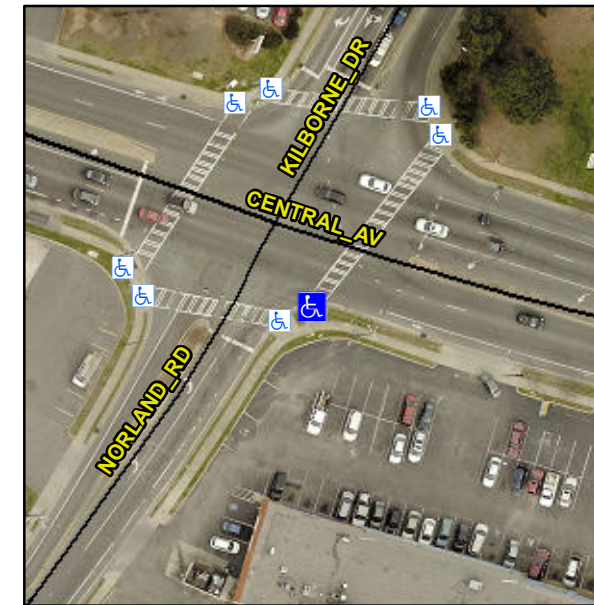
RT RP < 5%

R304.3.2

Compliance	Description	Data	Compliance	Description	Data
N/A	Ramp Length LT (in)	36.5	N/A	Ramp Length RT (in)	43.0
Yes	Ramp Width LT (in)	60.5	Yes	Ramp Width RT (in)	60.5
No	Ramp Slope LT (%)	8.5	Yes	Ramp Slope RT (%)	4.0
Yes	Ramp XSlope LT (%)	0.5	Yes	Ramp XSlope RT (%)	1.8
N/A	Landing Length (in)	N/A	N/A	DWS Provided?	N/A
N/A	Landing Width (in)	N/A	N/A	DWS Contrast?	N/A
N/A	Landing Slope (%)	N/A	N/A	DWS Length (in)	N/A
N/A	Landing X Slope (%)	N/A	N/A	DWS Full Width?	N/A
N/A	Landing Curb? (Y/N)	N/A	N/A	DWS Offset (in)	N/A
N/A	Shared Landing?	N/A			
N/A	Gutter Ponding?	N/A	N/A	Gutter Slope (%)	N/A
N/A	Gutter Lip Ht (in)	N/A	N/A	Gutter X Slope (%)	N/A
N/A	Painted X Walk1?	Yes	N/A	Painted X Walk2?	N/A
	X Walk 1 Direction	To NE		X Walk 2 Direction	N/A
N/A	X Walk 1 Width (in)	83.0	N/A	X Walk 2 Width (in)	N/A
	X Walk 1 Slope (%)	2.5		X Walk 2 Slope (%)	N/A
	X Walk 1 X Slope (%)	2.2		X Walk 2 X Slope (%)	N/A
N/A	Ramp inside XWalk1?	Yes	N/A	Ramp inside XWalk2?	N/A

Remove & Replace Entire Ramp.
