Access Compliance Report

Public Rights-of-Way

(Curb Ramps)

Intersection ID: 10186	Main Street: HORNWOOD_CT	Cross Street: RIDGEWELL_CT	Location: NW
ADA ID: 2FD69727F50A	Ramp Type: Perp	Initial Pass/Fail: Fail	Overall Compliance: No
Severity Score: 30			
Codes/Mitigation Info/Possible Solution		Field Measurements/Component Compliance

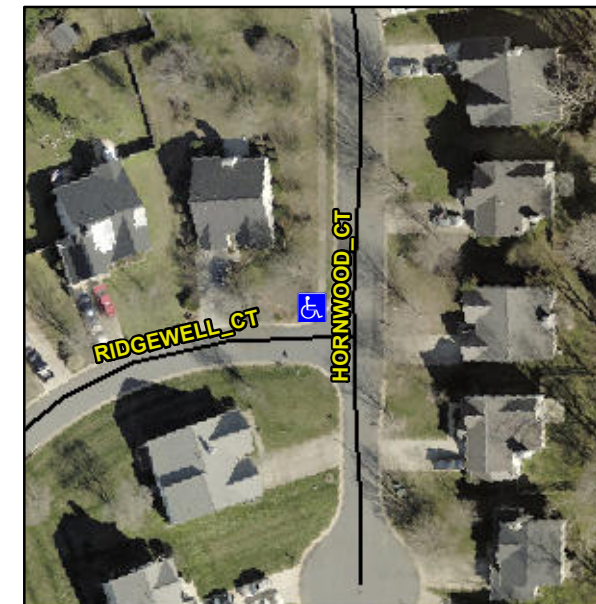
Compliance	Description	Data	Compliance	Description	Data
N/A	Ramp Length (in)	96.0	Yes	Ramp Slope (%)	5.6
No	Ramp Width (in)	34.5	No	Ramp XSlope (%)	6.3
N/A	Flare Type LT	N/A	N/A	Flare Type RT	N/A
N/A	Flare Slope LT (%)	N/A	N/A	Flare Slope RT (%)	N/A
N/A	Flare Traversable LT?	N/A	N/A	Flare Traversable RT?	N/A
N/A	Landing Length (in)	N/A	N/A	DWS Provided?	N/A
N/A	Landing Width (in)	N/A	N/A	DWS Contrast?	N/A
N/A	Landing Slope (%)	N/A	N/A	DWS Length (in)	N/A
N/A	Landing X Slope (%)	N/A	N/A	DWS Full Width?	N/A
N/A	Landing Curb? (Y/N)	N/A	N/A	DWS Offset (in)	N/A
N/A	Shared Landing?	N/A			
N/A	Gutter Ponding?	N/A	N/A	Gutter Slope (%)	N/A
N/A	Gutter Lip Ht (in)	1.0	N/A	Gutter X Slope (%)	N/A
N/A	Painted X Walk1?	No	N/A	Painted X Walk2?	N/A
	X Walk 1 Direction	To S		X Walk 2 Direction	N/A
N/A	X Walk 1 Width (in)	N/A	N/A	X Walk 2 Width (in)	N/A
	X Walk 1 Slope (%)	5.3		X Walk 2 Slope (%)	N/A
	X Walk 1 X Slope (%)	3.2		X Walk 2 X Slope (%)	N/A

N/A	Ramp inside XWalk1?	N/A	N/A	Ramp inside XWalk2?	N/A
	Road Slope (%)	N/A	N/A	Clear Space?	N/A
	Road X Slope (%)	N/A	N/A	Clear Space to XWalk (in)	N/A
N/A	Any Obstructions?	N/A	N/A	Storm Grate/Utility Hazard?	N/A
	Obstruction Type			Storm Grate/Utility Type	
		N/A			N/A
			Yes	Surface Condition? (G/P)	Good

Possible Solutions:

Remove & Replace Entire Ramp.

R304.5.1, R304.5.3
