Access Compliance Report Public Rights-of-Way (Curb Ramps)

Intersection ID: 51370 Main Street: UNIVERSITY_POINTE_BV Cross Street: IKEA_BV Location: NE **Overall Compliance: No** ADA ID: 2FE376704E15 Ramp Type: Perp Initial Pass/Fail: Fail Severity Score: 13.75

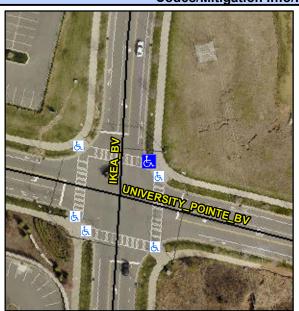
. tap =0g ()			. tamp 5.5p5 (75)	•.•
Yes	Ramp Width (in)	59.0	Yes	Ramp XSlope (%)	3.7
N/A	Flare Type LT	N/A	N/A	Flare Type RT	N/A
N/A	Flare Slope LT (%)	N/A	N/A	Flare Slope RT (%)	N/A
N/A	Flare Traversable LT?	N/A	N/A	Flare Traversable RT?	N/A
N/A	Landing Length (in)	N/A	N/A	DWS Provided?	N/A
N/A	Landing Width (in)	N/A	N/A	DWS Contrast?	N/A
N/A	Landing Slope (%)	N/A	N/A	DWS Length (in)	N/A
N/A	Landing X Slope (%)	N/A	N/A	DWS Full Width?	N/A
N/A	Landing Curb? (Y/N)	N/A	N/A	DWS Offset (in)	N/A
N/A	Shared Landing?	N/A			
N/A	Gutter Ponding?	N/A	N/A	Gutter Slope (%)	N/A
N/A	Gutter Lip Ht (in)	N/A	N/A	Gutter X Slope (%)	N/A
N/A	Painted X Walk1?	Yes	N/A	Painted X Walk2?	N/A
	X Walk 1 Direction	To NW		X Walk 2 Direction	N/A
N/A	X Walk 1 Width (in)	112.0	N/A	X Walk 2 Width (in)	N/A
	X Walk 1 Slope (%)	1.1		X Walk 2 Slope (%)	N/A
	X Walk 1 X Slope (%)	7.4		X Walk 2 X Slope (%)	N/A
N/A	Ramp inside XWalk1?	Yes	N/A	Ramp inside XWalk2?	N/A

Road Slope (%)	N/A	N/A	Clear Space?	N/A
	Road X Slope (%)	N/A	N/A	Clear Space to XWalk (in)	N/A
N/A	Any Obstructions?	N/A	N/A	Storm Grate/Utility Hazard?	N/A
	Obstruction Type		l	Storm Grate/Utility Type	
		N/A			N/A
			Yes	Surface Condition? (G/P)	Good
	and all the

-055ible 30iution		Field Me
Possible Solutions:	Compl	iance Description
Remove & Replace Entire Ramp.	N/A	Ramp Length (in)
·	Yes	Ramp Width (in)
	N/A	Flare Type LT
	N/A	Flare Slope LT (%)
	N/A	Flare Traversable LT
	N/A	Landing Length (in)
Surveyor Notes:	N/A	Landing Width (in)
N/A	N/A	Landing Slope (%)
	N/A	Landing X Slope (%)
	N/A	Landing Curb? (Y/N)
	N/A	Shared Landing?
PROW/ADA:	N/A	Gutter Ponding?
Not Found, R304.2.2	N/A	Gutter Lip Ht (in)
	N/A	Painted X Walk1?
		X Walk 1 Direction
	N/A	X Walk 1 Width (in)
		X Walk 1 Slope (%)
		X Walk 1 X Slope (%
	N/A	Ramp inside XWalk1
		Road Slope (%)

1850.00
