# Access Compliance Report

## Public Rights-of-Way

### (Curb Ramps)

Intersection ID: 10017853	Main Street: N_GRAHAM_ST	Cross Street: N/A	Location: E
ADA ID: 2FE47963F41A	Ramp Type: PerpDiag	Initial Pass/Fail: Fail	Overall Compliance: No
Severity Score: 37.5			
Codes/Mitigation Info/Possible Solution		Field Measurements/Component Compliance

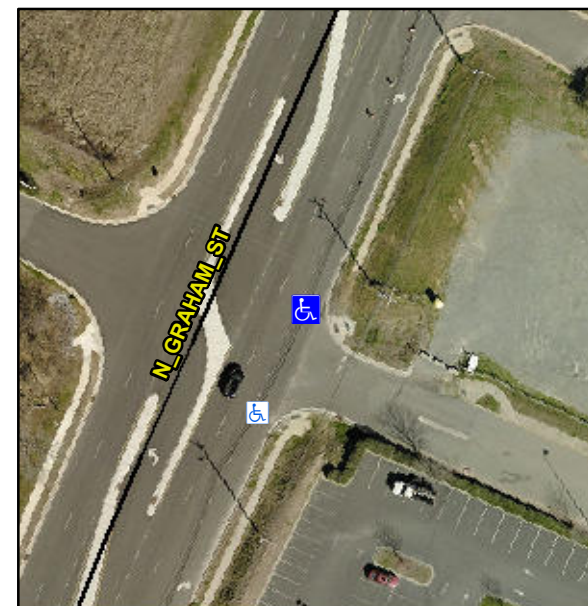
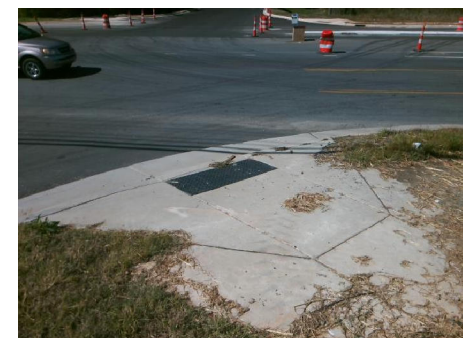
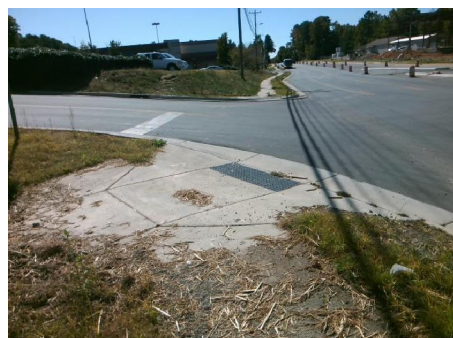
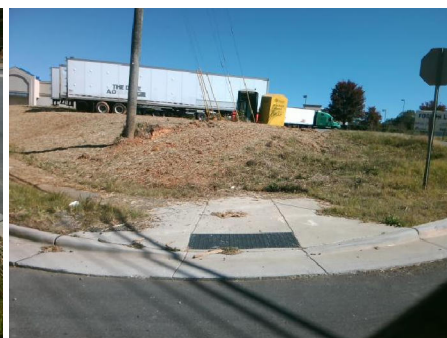
**Not Found, R304.2.2, R304.5.3**

Compliance	Description	Data	Compliance	Description	Data
N/A	Ramp Length (in)	93.0	No	Ramp Slope (%)	8.9
Yes	Ramp Width (in)	52.5	No	Ramp XSlope (%)	8.5
N/A	Flare Type LT	N/A	N/A	Flare Type RT	N/A
N/A	Flare Slope LT (%)	N/A	N/A	Flare Slope RT (%)	N/A
N/A	Flare Traversable LT?	N/A	N/A	Flare Traversable RT?	N/A
N/A	Landing Length (in)	N/A	N/A	DWS Provided?	N/A
N/A	Landing Width (in)	N/A	N/A	DWS Contrast?	N/A
N/A	Landing Slope (%)	N/A	N/A	DWS Length (in)	N/A
N/A	Landing X Slope (%)	N/A	N/A	DWS Full Width?	N/A
N/A	Landing Curb? (Y/N)	N/A	N/A	DWS Offset (in)	N/A
N/A	Shared Landing?	N/A			
N/A	Gutter Ponding?	N/A	N/A	Gutter Slope (%)	N/A
N/A	Gutter Lip Ht (in)	N/A	N/A	Gutter X Slope (%)	N/A
N/A	Painted X Walk1?	No	N/A	Painted X Walk2?	No
	X Walk 1 Direction	To NW		X Walk 2 Direction	To SW
N/A	X Walk 1 Width (in)	N/A	N/A	X Walk 2 Width (in)	N/A
	X Walk 1 Slope (%)	7.9		X Walk 2 Slope (%)	1.8
	X Walk 1 X Slope (%)	2.3		X Walk 2 X Slope (%)	11.0

N/A	Ramp inside XWalk1?	N/A	N/A	Ramp inside XWalk2?	N/A
	Road Slope (%)	6.8	N/A	Clear Space?	N/A
	Road X Slope (%)	8.6	N/A	Clear Space to XWalk (in)	N/A
N/A	Any Obstructions?	N/A	N/A	Storm Grate/Utility Hazard?	N/A
	Obstruction Type			Storm Grate/Utility Type	
		N/A			N/A
			Yes	Surface Condition? (G/P)	Good

**Remove & Replace Curb Ramp With Two New Directional Ramps or Equivalent.**
