Access Compliance Report

Public Rights-of-Way

(Curb Ramps)

Intersection ID: 13715	Main Street: E_MOREHEAD_ST	Cross Street: ROYAL_CT	Location: N
ADA ID: 2FE5EA1CCF31	Ramp Type: PerpDiag	Initial Pass/Fail: Fail	Overall Compliance: No
Severity Score: 13.75			
Codes/Mitigation Info/Possible Solution		Field Measurements/Component Compliance

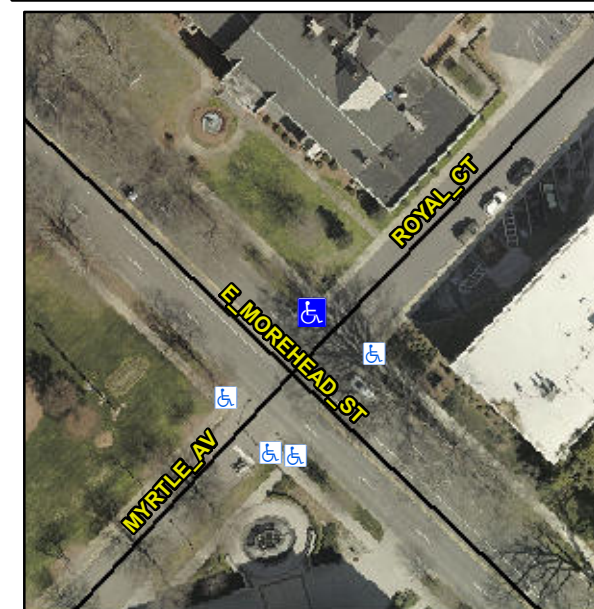
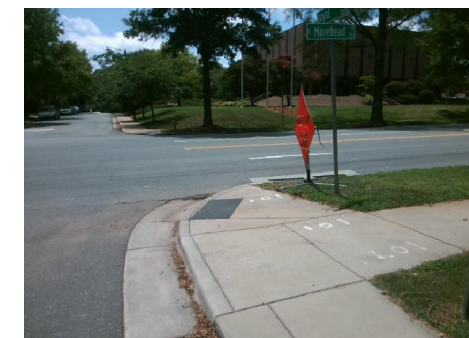
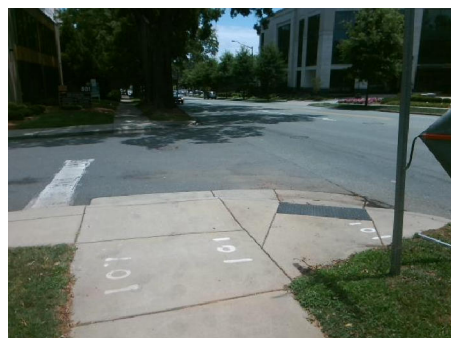
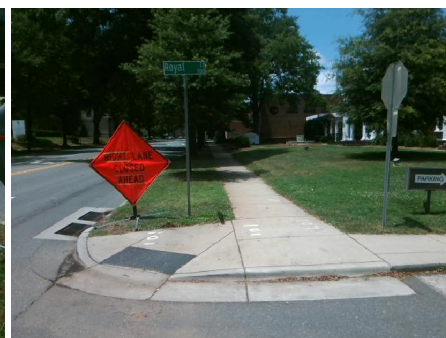
Not Found, R304.2.2, R304.5.3

Compliance	Description	Data	Compliance	Description	Data
N/A	Ramp Length (in)	66.0	No	Ramp Slope (%)	9.2
Yes	Ramp Width (in)	48.0	No	Ramp XSlope (%)	2.9
N/A	Flare Type LT	N/A	N/A	Flare Type RT	N/A
N/A	Flare Slope LT (%)	N/A	N/A	Flare Slope RT (%)	N/A
N/A	Flare Traversable LT?	N/A	N/A	Flare Traversable RT?	N/A
N/A	Landing Length (in)	N/A	N/A	DWS Provided?	N/A
N/A	Landing Width (in)	N/A	N/A	DWS Contrast?	N/A
N/A	Landing Slope (%)	N/A	N/A	DWS Length (in)	N/A
N/A	Landing X Slope (%)	N/A	N/A	DWS Full Width?	N/A
N/A	Landing Curb? (Y/N)	N/A	N/A	DWS Offset (in)	N/A
N/A	Shared Landing?	N/A			
N/A	Gutter Ponding?	N/A	N/A	Gutter Slope (%)	N/A
N/A	Gutter Lip Ht (in)	N/A	N/A	Gutter X Slope (%)	N/A
N/A	Painted X Walk1?	No	N/A	Painted X Walk2?	No
	X Walk 1 Direction	To SW		X Walk 2 Direction	To SE
N/A	X Walk 1 Width (in)	N/A	N/A	X Walk 2 Width (in)	N/A
	X Walk 1 Slope (%)	6.0		X Walk 2 Slope (%)	0.7
	X Walk 1 X Slope (%)	0.1		X Walk 2 X Slope (%)	0.9

N/A	Ramp inside XWalk1?	N/A	N/A	Ramp inside XWalk2?	N/A
	Road Slope (%)	0.5	N/A	Clear Space?	N/A
	Road X Slope (%)	4.0	N/A	Clear Space to XWalk (in)	N/A
N/A	Any Obstructions?	N/A	N/A	Storm Grate/Utility Hazard?	N/A
	Obstruction Type			Storm Grate/Utility Type	
		N/A			N/A
		Yes		Surface Condition? (G/P)	Good

Remove & Replace Curb Ramp With Two New Directional Ramps or Equivalent.
