Access Compliance Report

Public Rights-of-Way

(Curb Ramps)

Intersection ID: 45175	Main Street: LINDEN_TREE_LN	Cross Street: TORRELLE_DR	Location: N
ADA ID: 2FE6EFDB85F4	Ramp Type: BlendTrans1	Initial Pass/Fail: Fail	Overall Compliance: No
Severity Score: 10			
Codes/Mitigation Info/Possible Solution		Field Measurements/Component Compliance

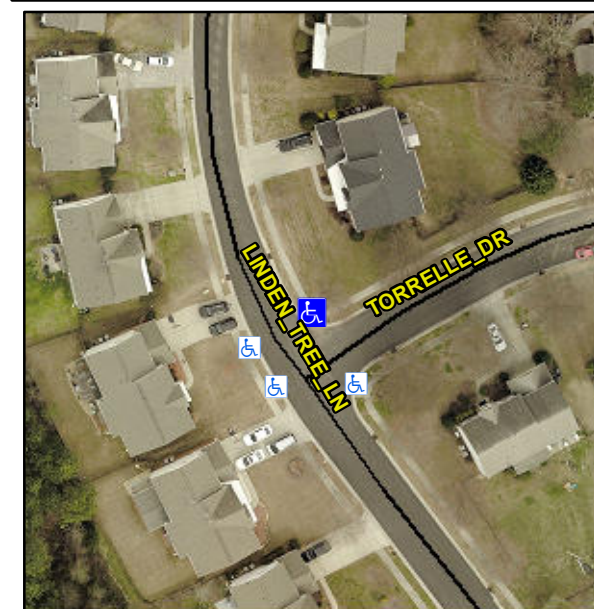
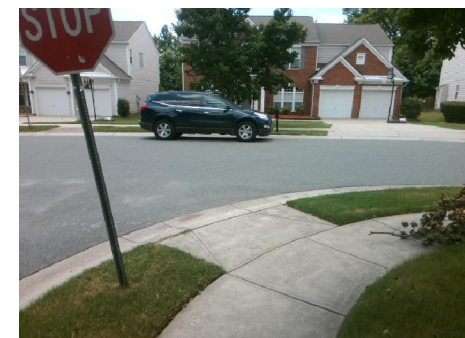
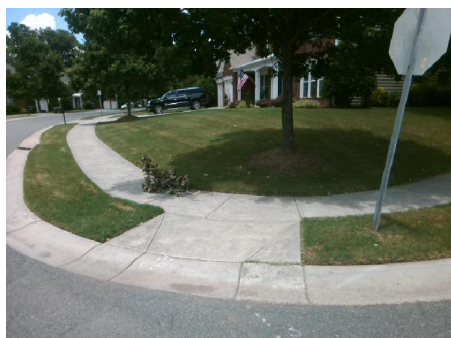
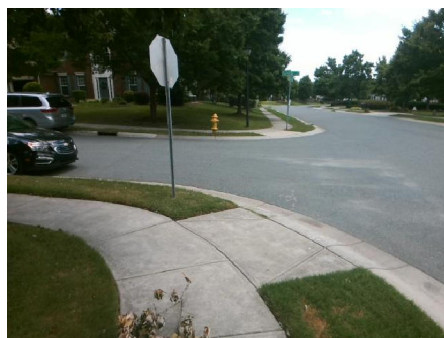
Not Found, R304.5.1, R304.5.3

Compliance	Description	Data	Compliance	Description	Data
N/A	Ramp Length (in)	47.0	Yes	BlendTrans Slope (%)	4.2
No	Ramp Width (in)	45.5	No	BlendTrans XSlope (%)	2.9
N/A	Flare Type LT	N/A	N/A	Flare Type RT	N/A
N/A	Flare Slope LT (%)	N/A	N/A	Flare Slope RT (%)	N/A
N/A	Flare Traversable LT?	N/A	N/A	Flare Traversable RT?	N/A
N/A	Landing Length (in)	N/A	N/A	DWS Provided?	N/A
N/A	Landing Width (in)	N/A	N/A	DWS Contrast?	N/A
N/A	Landing Slope (%)	N/A	N/A	DWS Length (in)	N/A
N/A	Landing X Slope (%)	N/A	N/A	DWS Full Width?	N/A
N/A	Landing Curb? (Y/N)	N/A	N/A	DWS Offset (in)	N/A
N/A	Shared Landing?	N/A			
N/A	Gutter Ponding?	N/A	N/A	Gutter Slope (%)	N/A
N/A	Gutter Lip Ht (in)	N/A	N/A	Gutter X Slope (%)	N/A
N/A	Painted X Walk1?	No	N/A	Painted X Walk2?	No
	X Walk 1 Direction	To SW		X Walk 2 Direction	To SE
	X Walk 1 Width (in)	N/A		X Walk 2 Width (in)	N/A
	X Walk 1 Slope (%)	3.8		X Walk 2 Slope (%)	1.1
	X Walk 1 X Slope (%)	1.3		X Walk 2 X Slope (%)	0.4

N/A	Ramp inside XWalk1?	N/A	N/A	Ramp inside XWalk2?	N/A
	Road Slope (%)	1.8		Clear Space?	N/A
	Road X Slope (%)	1.4	N/A	Clear Space to XWalk (in)	N/A
N/A	Any Obstructions?	N/A	N/A	Storm Grate/Utility Hazard?	N/A
	Obstruction Type			Storm Grate/Utility Type	
		N/A			N/A
			Yes	Surface Condition? (G/P)	Good
			No	Curb Slope (%)	23.1

Possible Solutions:

Remove & Replace Curb Ramp With Two New Directional Ramps or Equivalent.
