Access Compliance Report

Public Rights-of-Way

(Curb Ramps)

Intersection ID: 51507	Main Street: ALDERSON_DR	Cross Street: NETHERTON_LN	Location:	E
ADA ID: 2FF0F90F7C21	Ramp Type: Perp	Initial Pass/Fail: Fail	Overall Compliance: No	Severity Score: 10
Codes/Mitigation Info/Possible Solution		Field Measurements/Component Compliance

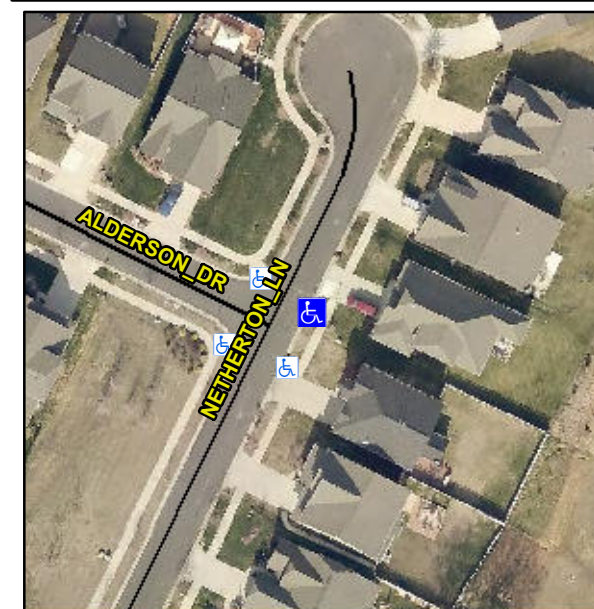
Not Found, R304.5.1, R304.5.3

Compliance	Description	Data	Compliance	Description	Data
N/A	Ramp Length (in)	71.0	Yes	Ramp Slope (%)	6.2
No	Ramp Width (in)	46.5	No	Ramp XSlope (%)	3.9
N/A	Flare Type LT	N/A	N/A	Flare Type RT	N/A
N/A	Flare Slope LT (%)	N/A	N/A	Flare Slope RT (%)	N/A
N/A	Flare Traversable LT?	N/A	N/A	Flare Traversable RT?	N/A
N/A	Landing Length (in)	N/A	N/A	DWS Provided?	N/A
N/A	Landing Width (in)	N/A	N/A	DWS Contrast?	N/A
N/A	Landing Slope (%)	N/A	N/A	DWS Length (in)	N/A
N/A	Landing X Slope (%)	N/A	N/A	DWS Full Width?	N/A
N/A	Landing Curb? (Y/N)	N/A	N/A	DWS Offset (in)	N/A
N/A	Shared Landing?	N/A			
N/A	Gutter Ponding?	N/A	N/A	Gutter Slope (%)	N/A
N/A	Gutter Lip Ht (in)	N/A	N/A	Gutter X Slope (%)	N/A
N/A	Painted X Walk1?	No	N/A	Painted X Walk2?	N/A
	X Walk 1 Direction	To NW		X Walk 2 Direction	N/A
N/A	X Walk 1 Width (in)	N/A	N/A	X Walk 2 Width (in)	N/A
	X Walk 1 Slope (%)	1.9		X Walk 2 Slope (%)	N/A
	X Walk 1 X Slope (%)	3.7		X Walk 2 X Slope (%)	N/A

N/A	Ramp inside XWalk1?	N/A	N/A	Ramp inside XWalk2?	N/A
	Road Slope (%)	N/A	N/A	Clear Space?	N/A
	Road X Slope (%)	N/A	N/A	Clear Space to XWalk (in)	N/A
N/A	Any Obstructions?	N/A	N/A	Storm Grate/Utility Hazard?	N/A
	Obstruction Type			Storm Grate/Utility Type	
		N/A			N/A
			Yes	Surface Condition? (G/P)	Good

Possible Solutions:

Remove & Replace Entire Ramp.
