Access Compliance Report

Public Rights-of-Way

(Curb Ramps)

Intersection ID: 14746	Main Street: ALBEMARLE_RD	Cross Street: WILGROVE_MINT_HILL_RD	Location: SE
ADA ID: 2FFC3D17FF87	Ramp Type: Perp	Initial Pass/Fail: Fail	Overall Compliance: No
Severity Score: 21.25			
Codes/Mitigation Info/Possible Solution		Field Measurements/Component Compliance

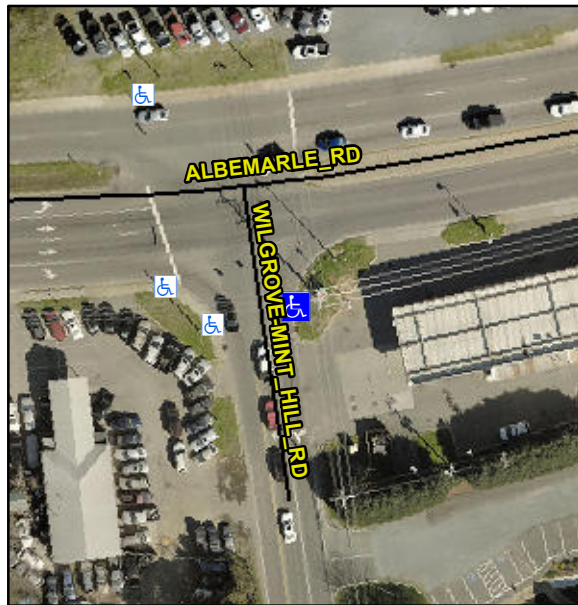
Not Found, R304.5.1, R304.2.2

Compliance	Description	Data	Compliance	Description	Data
N/A	Ramp Length (in)	64.0	No	Ramp Slope (%)	8.7
No	Ramp Width (in)	38.0	Yes	Ramp XSlope (%)	1.8
N/A	Flare Type LT	N/A	N/A	Flare Type RT	N/A
N/A	Flare Slope LT (%)	N/A	N/A	Flare Slope RT (%)	N/A
N/A	Flare Traversable LT?	N/A	N/A	Flare Traversable RT?	N/A
N/A	Landing Length (in)	N/A	N/A	DWS Provided?	N/A
N/A	Landing Width (in)	N/A	N/A	DWS Contrast?	N/A
N/A	Landing Slope (%)	N/A	N/A	DWS Length (in)	N/A
N/A	Landing X Slope (%)	N/A	N/A	DWS Full Width?	N/A
N/A	Landing Curb? (Y/N)	N/A	N/A	DWS Offset (in)	N/A
N/A	Shared Landing?	N/A			
N/A	Gutter Ponding?	Yes	N/A	Gutter Slope (%)	N/A
N/A	Gutter Lip Ht (in)	N/A	N/A	Gutter X Slope (%)	N/A
N/A	Painted X Walk1?	No	N/A	Painted X Walk2?	N/A
	X Walk 1 Direction	To W		X Walk 2 Direction	N/A
N/A	X Walk 1 Width (in)	N/A	N/A	X Walk 2 Width (in)	N/A
	X Walk 1 Slope (%)	0.0		X Walk 2 Slope (%)	N/A
	X Walk 1 X Slope (%)	2.2		X Walk 2 X Slope (%)	N/A

Possible Solutions:

Remove & Replace Entire Ramp.

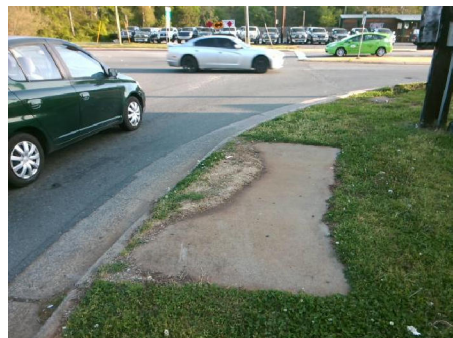
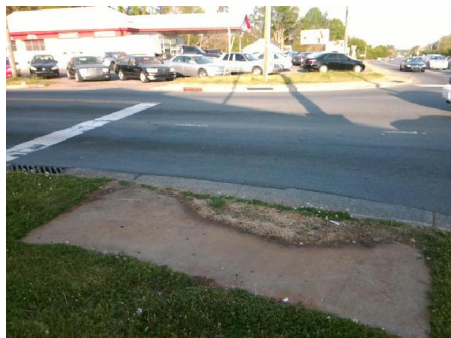
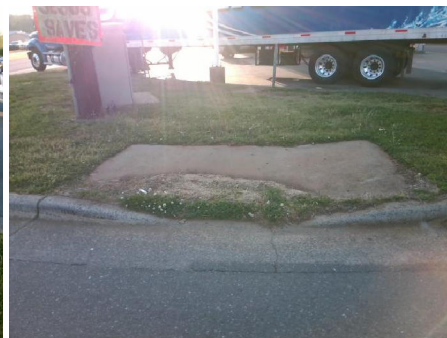
N/A	Ramp inside XWalk1?	N/A	N/A	Ramp inside XWalk2?	N/A
	Road Slope (%)	N/A	N/A	Clear Space?	N/A
	Road X Slope (%)	N/A	N/A	Clear Space to XWalk (in)	N/A
N/A	Any Obstructions?	N/A	N/A	Storm Grate/Utility Hazard?	N/A
	Obstruction Type			Storm Grate/Utility Type	
		N/A			N/A
		Yes		Surface Condition? (G/P)	Good
