# Access Compliance Report

## Public Rights-of-Way

### (Curb Ramps)

| Intersection ID: 51509 | Main Street: EASTFIELD_PARK_DR | Cross Street: NETHERTON_LN | Location: E |

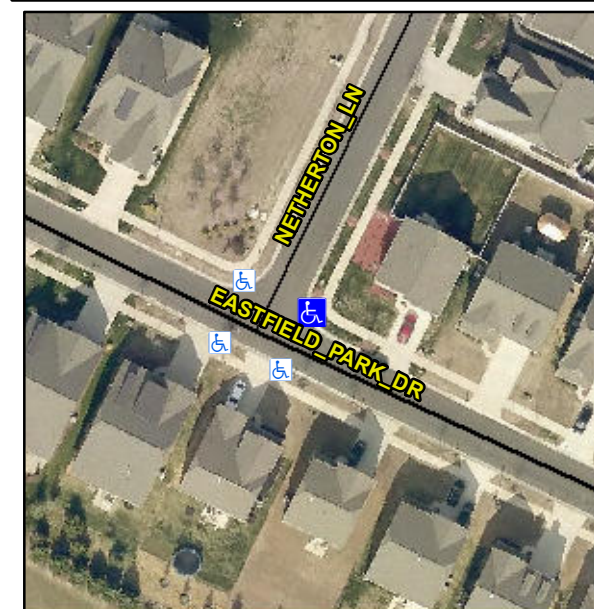
| ADA ID: 300492C3A040 | Ramp Type: PerpDiag | Initial Pass/Fail: Fail | Overall Compliance: No |
| Severity Score: 8.75 | | | |

**Not Found, R304.5.1**

| Compliance | Description | Data | Compliance | Description | Data |
|---|---|---|---|---|---|
| No | Ramp Width (in) | 47.0 | Yes | Ramp XSlope (%) | 1.4 |

**Remove & Replace Curb Ramp With Two New Directional Ramps or Equivalent.**

Total Cost: \$ 3200.00
